3.4 PLANNING CONSIDERATIONS FACILITY CONDITION ASSESSMENTS SUMMARY

HOPE SCHOOL & GILBERT WEST

7901 Knott Ave.
Buena Park, CA 90620

CONDITION ASSESSMENT

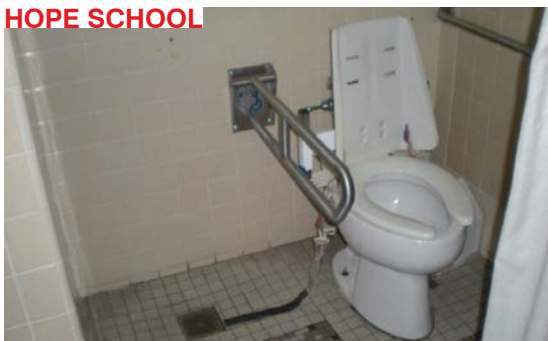
Additional specialized toilet facilities are needed.

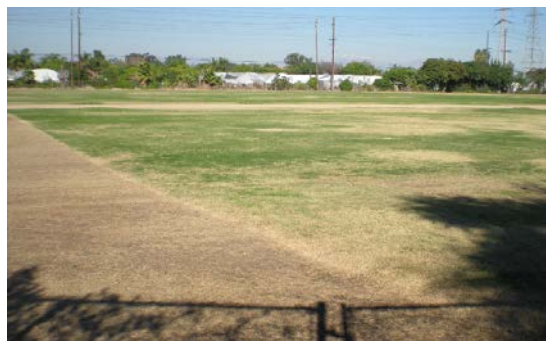
Replace irrigation, provide accessibility, rehabilitate fields & track.

The existing field and courtyard irrigation is in

poor condition and should be replaced at Hope School and Gilbert West. Improve courtyard areas throughout with new hardscape, landscape, seating, irrigation with smart controllers, shade structures and event lighting giving special consideration to the needs of the users.

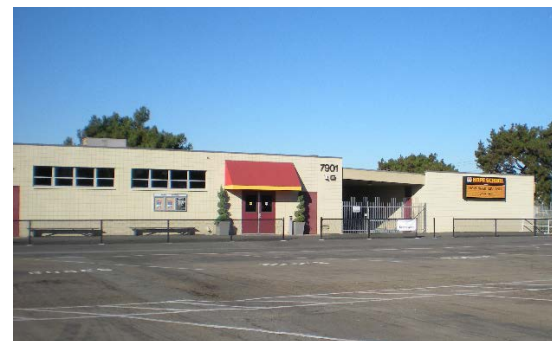
The drop-off area requires major improvement. Seventy wheelchairs are currently trying to fit through a bottleneck at Building 9. A waiting/seating/shaded area should be added at this location.

Need to improve drop-off/bottleneck for wheelchairs.

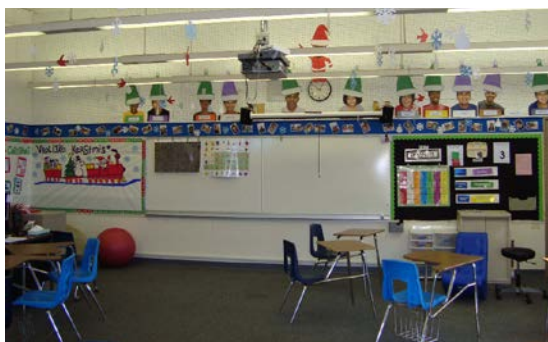
Replace carpeting with hard floors in classrooms.

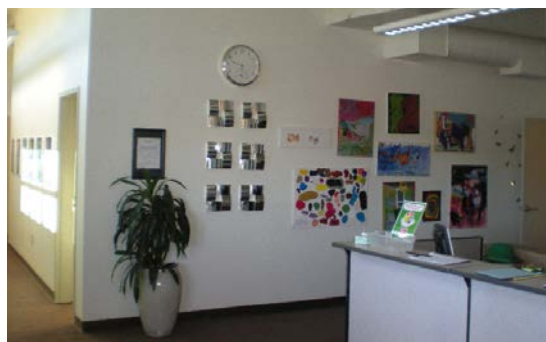
Building 9 was recently modernized.

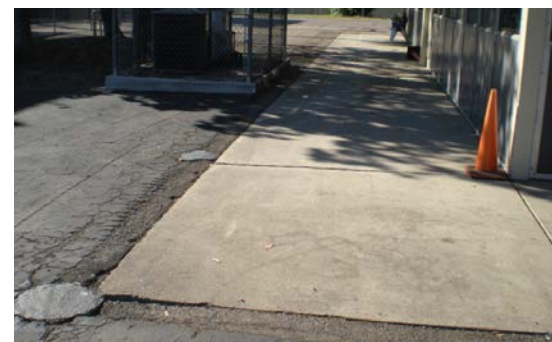
Currently, there are downspout issues at every building with water flowing down to the path of travel. Asphalt paving is in poor condition at all areas with large gaps throughout the campus grounds creating trip hazards (213,750 s.f.). Accessible parking is required at both the Hope School and Gilbert West parking lots.

Paving in poor condition across campus.

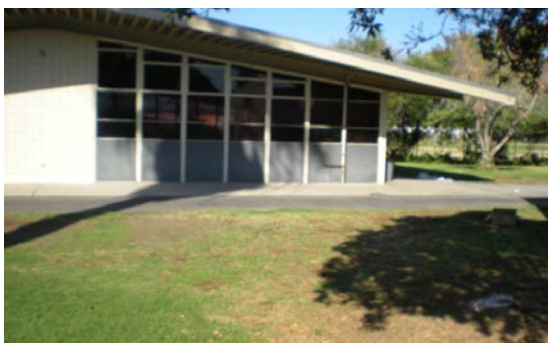
Landscape and irrigation in need of renovation.

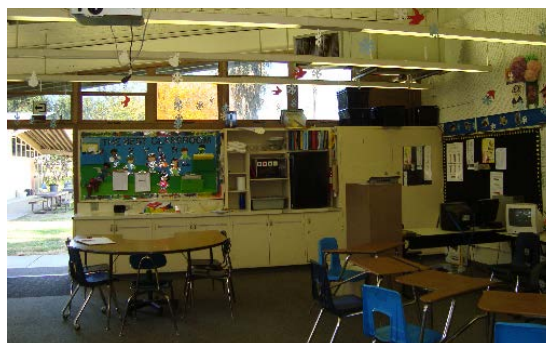
Classrooms require modernization with special needs.

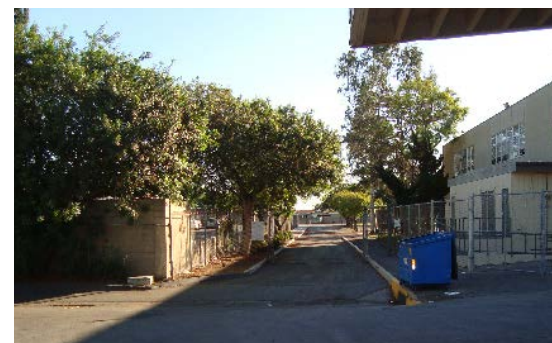
Drainage issues at the south of campus.

Improve drainage south of the campus in the alleyway.

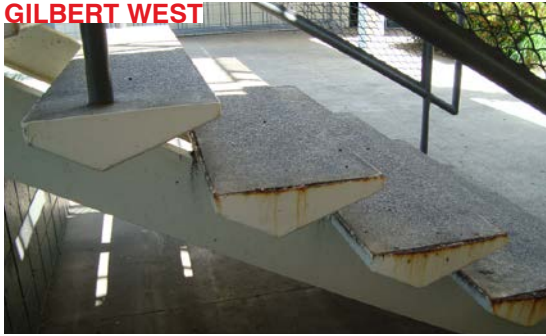
Stairs in poor condition.

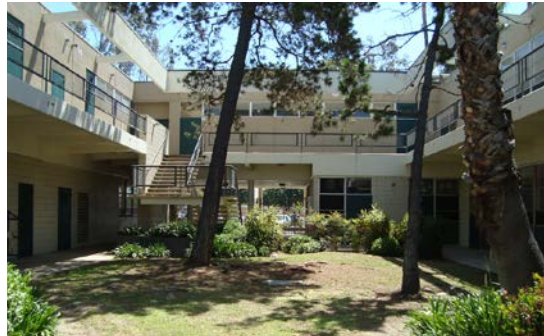
No ADA access to upper level. Provide elevator.

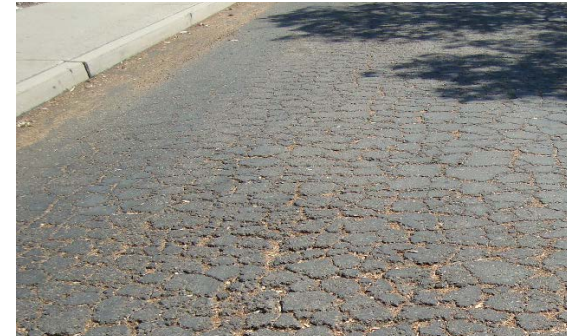
AC paving poor at parking lot.

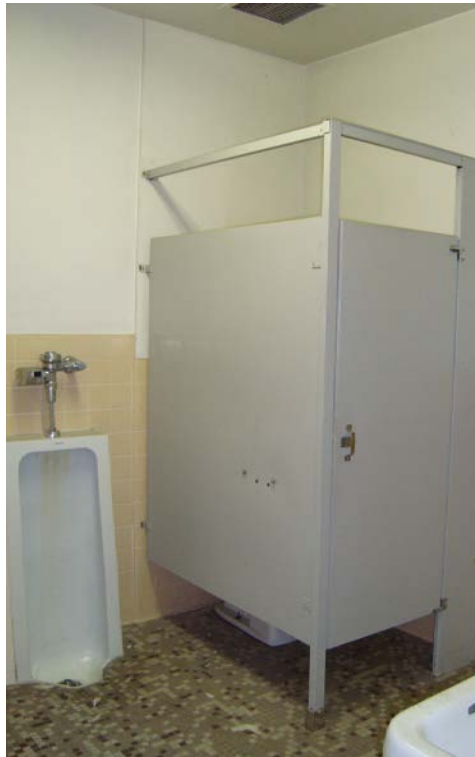
Provide ADA accessible restrooms.

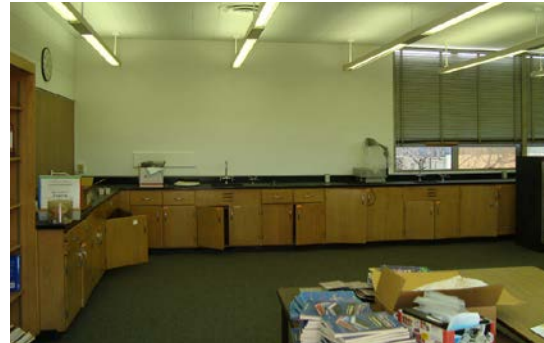
Provide ADA accessible casework in science classrooms.

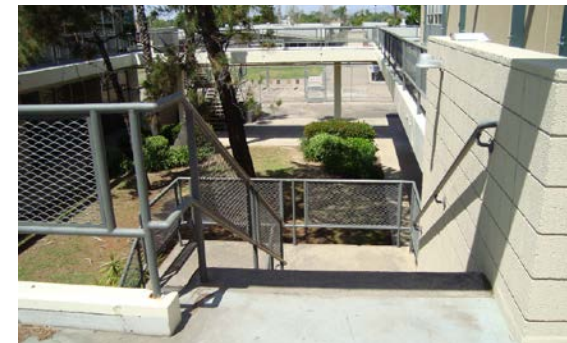
Accessible handrails needed at stairs and at upper level.

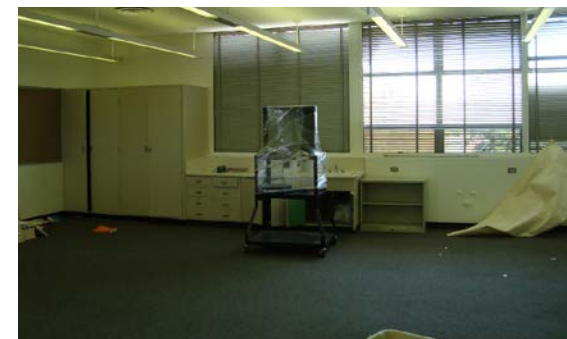
Standard modernization needed in classrooms.
