PLANNING CONSIDERATIONS FACILITY CONDITION ASSESSMENTS SUMMARY

BALL JR. HIGH SCHOOL

1500 W. Ball Rd.
Anaheim, CA 92802

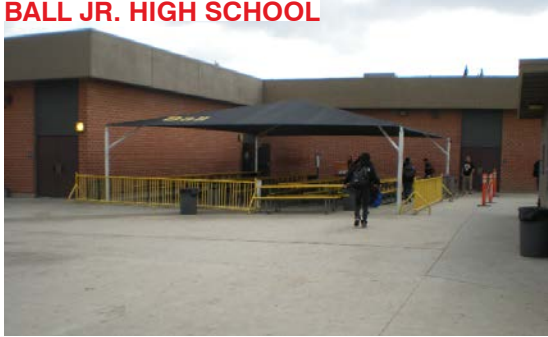
The condition of the central quad area is poor. The campus is in need of better gathering and lunch

Need to add lunch shelters.

areas with accompanying shade structures, seating, paving and landscape (23,500 s.f.). The landscape at the existing courtyard areas between buildings needs to be replaced (43,000 s.f.). Irrigation needs to be replaced throughout the campus. The bike rack enclosure needs to be relocated.

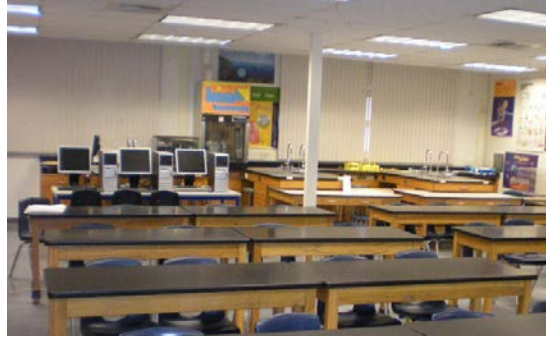
Currently, the school is unable to meet the Common Core testing requirements with the existing number of computer labs. It was suggested the hexagonal building in the center of the campus be converted to a media center and computer lab function in lieu of standard classrooms. It is difficult to teach in the irregular shaped rooms that may be better suited for library and computer lab use.

Need computer labs to meet Common Core requirements.

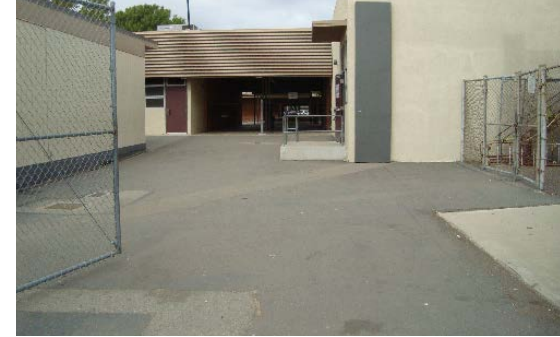
Overall traffic, parking, and circulation function well at Ball Jr. High School. Additional parking spaces are needed. The existing condition of the asphalt is poor and needs to be replaced. Conditions are especially poor at the front parking lot, main parking lot, amphitheater, basketball courts and west campus areas (160,500 s.f.). The existing concrete is generally in fair condition with some areas that need to be replaced due to cracking (26,000 s.f.).

Poor asphalt conditions on campus present several path-of-travel issues. The 2002 modernization addressed accessible parking. However, parking signage will still need to be brought up to current code. All drinking fountains need to be upgraded to meet ADA requirements.

Poor asphalt conditions throughout campus.

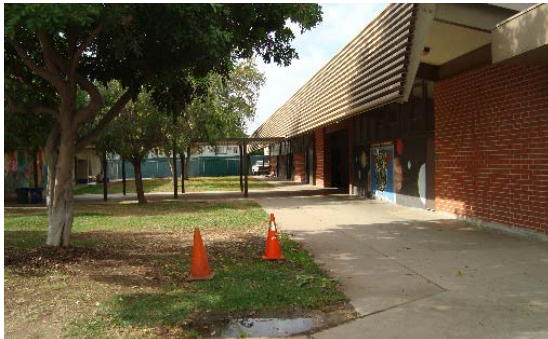
Ponding, drainage and sewer problems along the central north/south corridor is a major issue. Severe sheet flow from the apartments north of the track floods the southwest corner of the campus. There are drainage problems south and northeast of the MPR and poor drainage to the east.

Major drainage/ponding issues in campus courtyards.

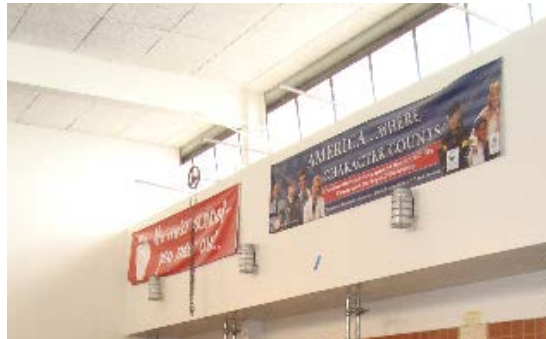
There are several issues to be addressed at the gymnasium, including the need for better ventilation and bleachers. The gym doors need to be replaced. Modernize girls and boys shower/locker rooms and coaches area. Provide showers to an appropriate level. Replace lockers to meet the current need. The clerestory windows in the shower/locker rooms are leaking and need to be replaced.

Replace leaking clerestory windows in locker rooms.

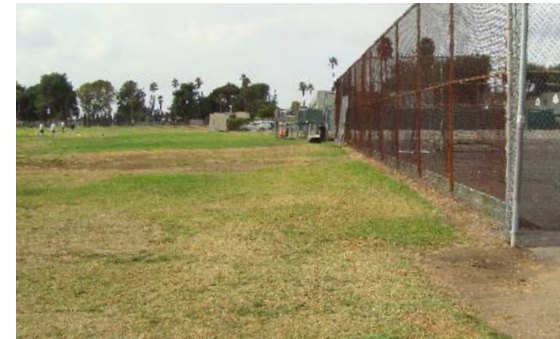
The existing playing fields are in fair to poor shape (14 acres) and in need of a new irrigation system. Existing tennis courts need to be resurfaced and their fencing replaced (43,800 s.f.).

Playing fields in fair to poor condition.

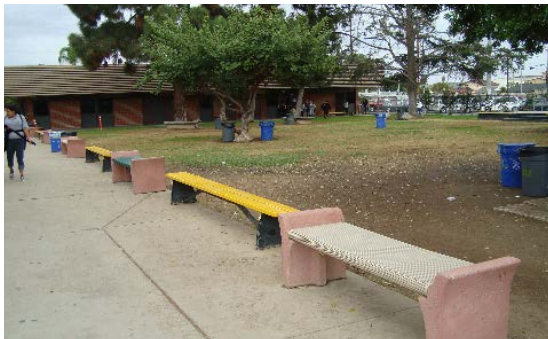
- ▶ The condition of the existing central quad area is poor. The campus needs better gathering and lunch areas with shade structures, seating, paving and landscape.

Campus quad in poor condition.

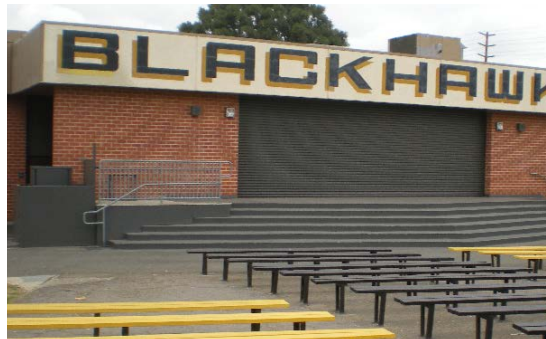
Repurpose amphitheater area.

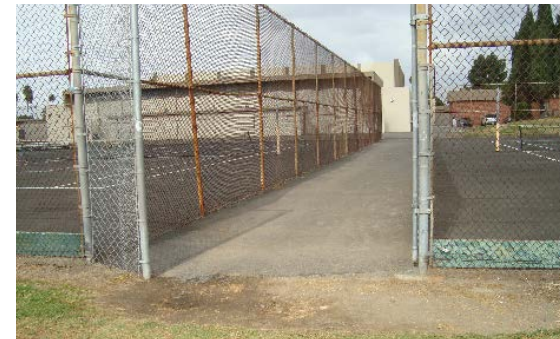
Perimeter fencing along the east side of the campus and parking lot gates need to be replaced. Consider adding security fencing along the front of the school. The total site fencing need is 1,800 l.f.

New fencing required in various areas.
