PLANNING CONSIDERATIONS FACILITY CONDITION ASSESSMENTS SUMMARY

LEXINGTON JR. HIGH SCHOOL

4351 Orange Ave.
Cypress, CA 90630

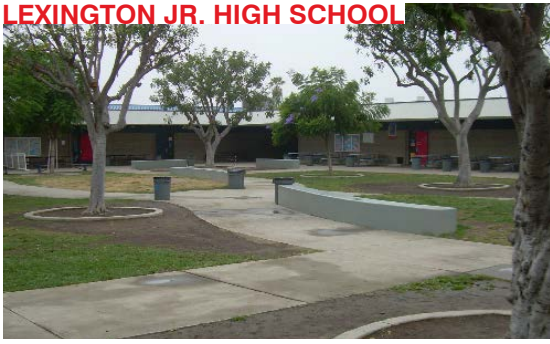
The central quad, which serves as an outdoor eating area, is in need of shade and site furnishings. It needs to be redesigned to address flooding issues.

Improve campus quad.

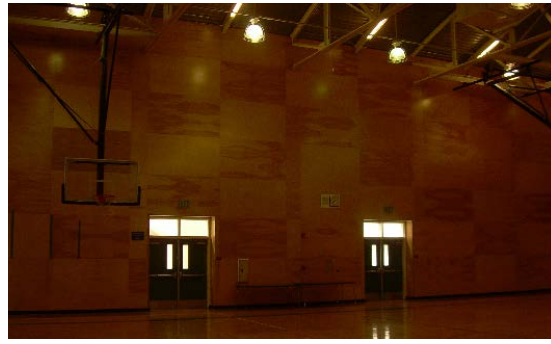
The Gymnasium floor needs to be refinished. The boys and girls locker rooms are in need of better ventilation and the boys restroom floor drains need to be lowered.

Gymnasium floor needs to be refinished.

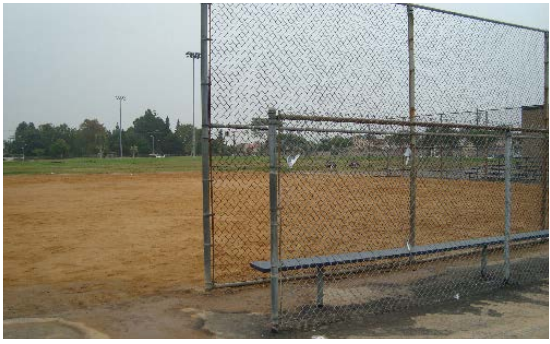
The existing tennis courts are in good condition. The softball field's infield is in poor condition, as is the backstop and dugout fencing. It has ponding issues that need to be addressed.

Softball infield and backstop are in poor condition.

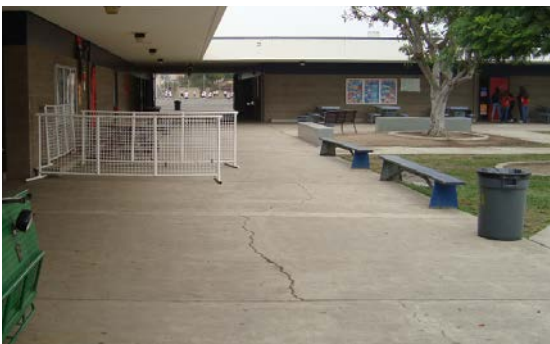
Campus traffic and circulation is good, although the site staff expressed the need for additional parking. Special event parking is directed to the turf playfields. Parking lots and perimeter asphalt conditions are good. Cross slope at the northwest corner perimeter road exceeds 2%. Overall site concrete is in poor condition (17,000 s.f.) and the central quad is especially poor (13,000 s.f.).

Campus concrete is in poor condition, especially at quad.

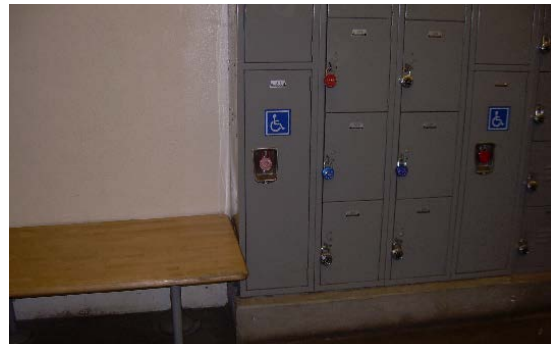
Boys and girls locker rooms need better ventilation.

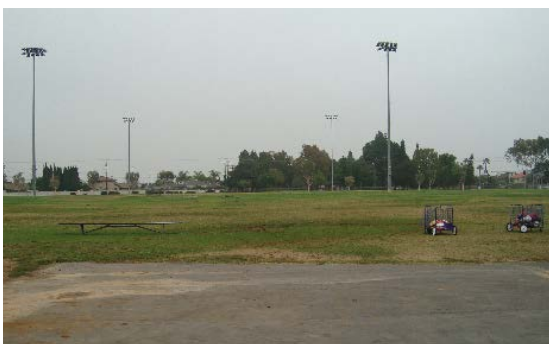
Lexington's playing fields (9 acres including track) need to be reconditioned. The fields receive heavy use by outside organizations. Existing sports field lighting is maintained by AYSO with separate electric meter through Southern California Edison.

Exterior field lighting maintained by AYSO.

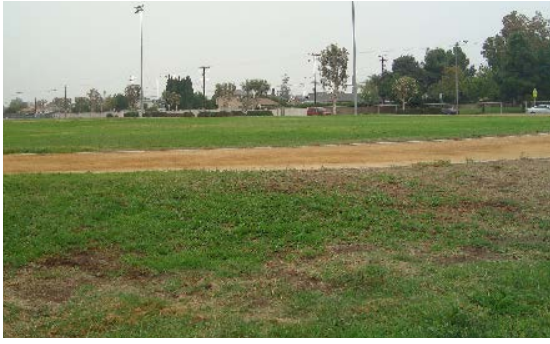
Playing fields are in poor condition.

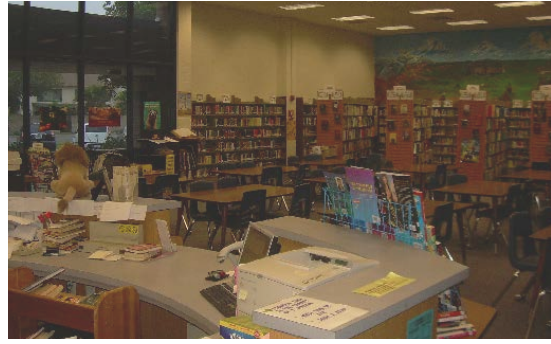
Library/Media Center is in need of an upgrade.

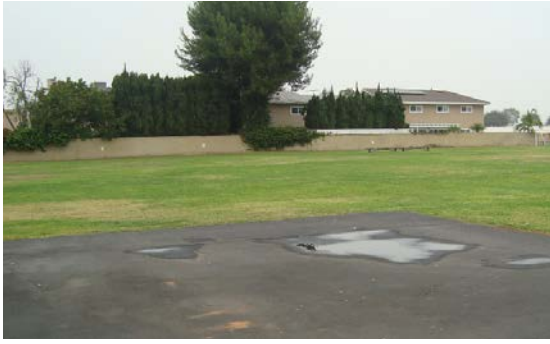
The campus landscape and irrigation (fields and grounds) were upgraded in 2007 and are in good condition. Minor ponding around campus needs to be addressed. Accessibility issues were addressed in 2007, as were the campus marquee and signage.

Minor ponding and flooding issues on campus.
