PLANNING CONSIDERATIONS FACILITY CONDITION ASSESSMENTS SUMMARY

TRIDENT EDUCATION CENTER

1800 West Ball Road
Anaheim, CA 92804

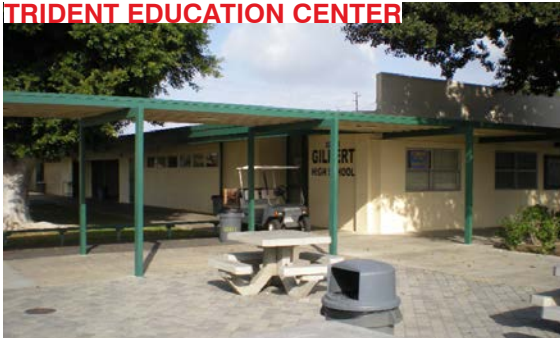
Shade structures are needed.

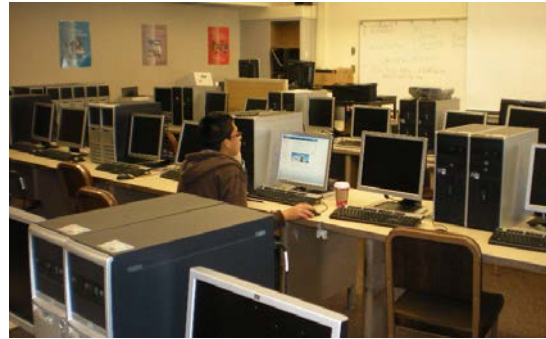
Need adequate science and computer labs.

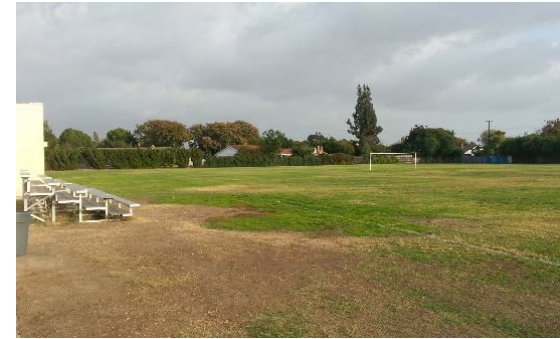
Both playing fields receive a lot of use and are in need of reconditioning. The northwest field irrigation is adequate but the south field irrigation needs to be replaced. Shade structures at CDS were installed in 2012.

Playing fields need reconditioning.

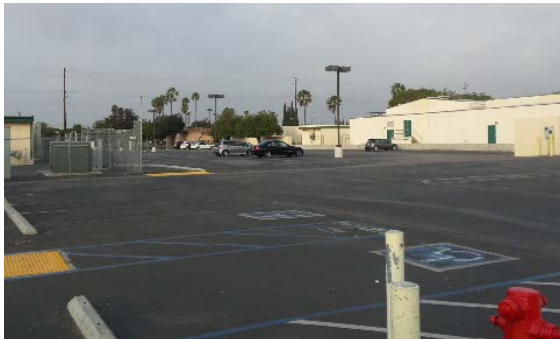
Parking lot is in need of renovation and improved traffic flow.

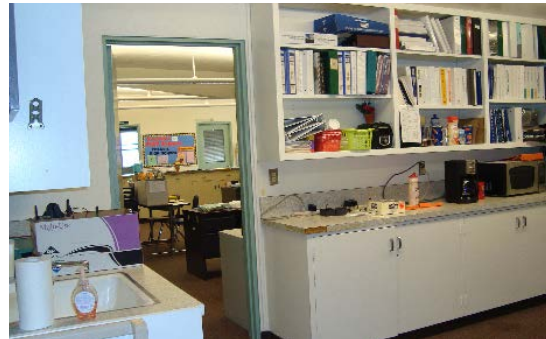
Currently, the administration building does not have adequate space to house a flexible staff that has to meet the needs of three programs. The administration building is in need of a major modernization. The school is in need of adequately housed and equipped science and computer labs to meet S.T.E.M. requirements. Classrooms need to be upgraded to meet Common Core.

Administration needs expansion.

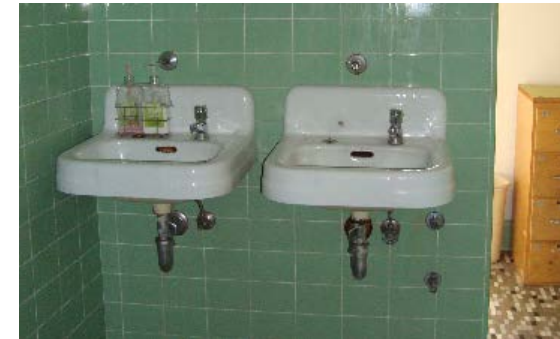
Restrooms are in need of upgrades.

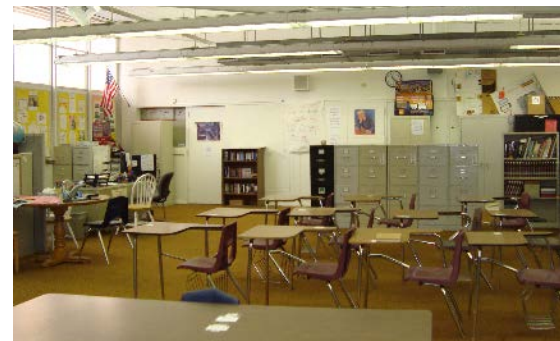
Upgrade classrooms.

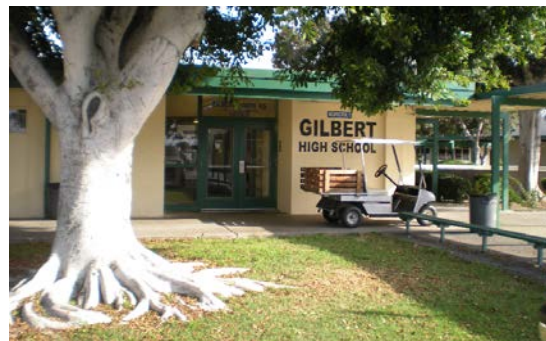
The entry to the campus from Ball Road requires a complete redesign to help identify the multiple programs while improving much needed curb appeal. Emphasize the entrance to the campus with a greater level of wayfinding and program identity.

Reorganize and emphasize campus entrance.

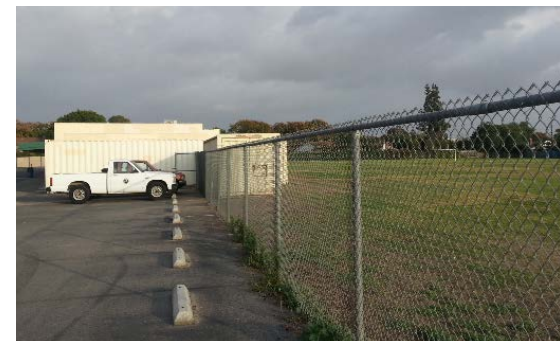
Security is a major concern along Ball Road. Fencing needs to be replaced at various campus boundaries as follows: Chainlink (2,500 l.f.) and ornamental steel (1,000 l.f.).

Need to replace fencing throughout.
