PLANNING CONSIDERATIONS | SECTION 3

CREATING SUSTAINABLE PLACES AND SPACES THAT ENRICH THE LIVES OF THOSE WHO USE THEM

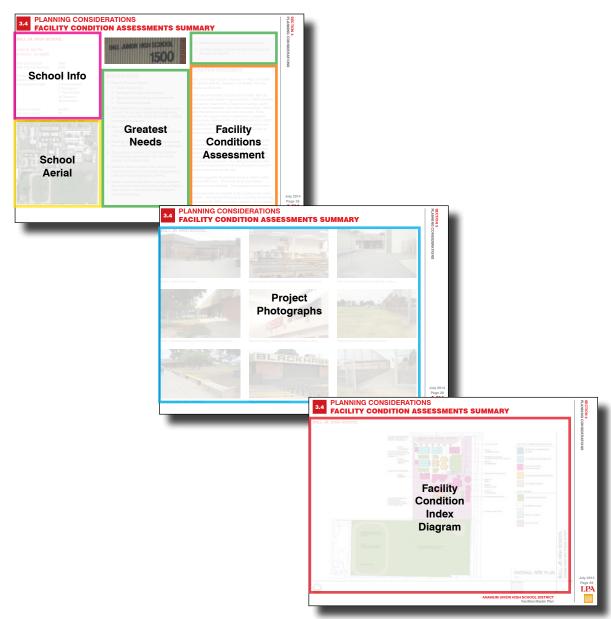
ANAHEIM UNION HIGH SCHOOL DISTRICT
Facilities Master Plan

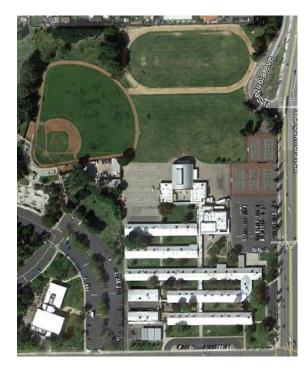
- ▶ Need to add more restrooms on campus.
- ▶ Secure classrooms facing Crescent Ave.

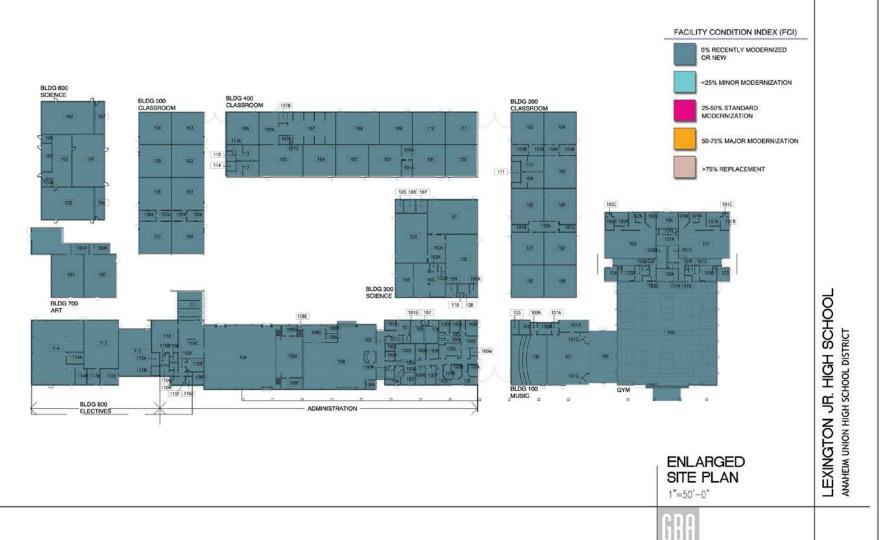
LEXINGTON JR. HIGH SCHOOL

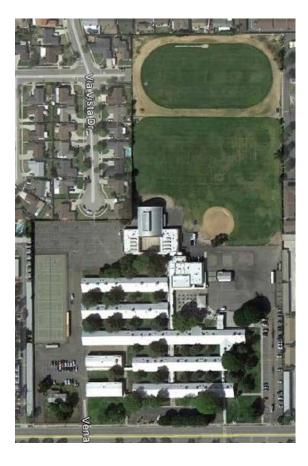
CONDITION ASSESSMENT

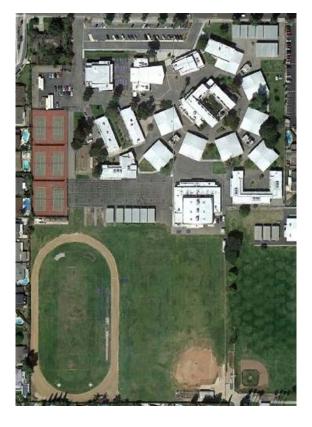
- ▶ Highest Program Needs:
 - o Library / Media Center technology upgrade.
 - o Classroom upgrades for 21st century learning.
- Relocate the band function from the new multipurpose building and build a permanent stage.
- Provide a central location for a new faculty lounge (approximately 1200 s.f.) should the existing location be repurposed.
- ▶ Need to improve site security/fencing.
- Need to fix landscape and hardscape campus wide.
- Need to relocate and expand the existing food service area.
- Shade structures.

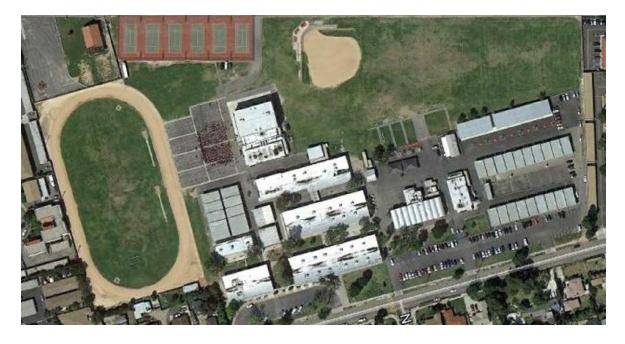
- ► Choir and band programs need to be adequately housed.
- Provide adequate science labs and library/ media center.
- Secure campus perimeter.
- Need to address parking/circulation issues on campus. Improve vehicular traffic flow and reconfigure parking lots.

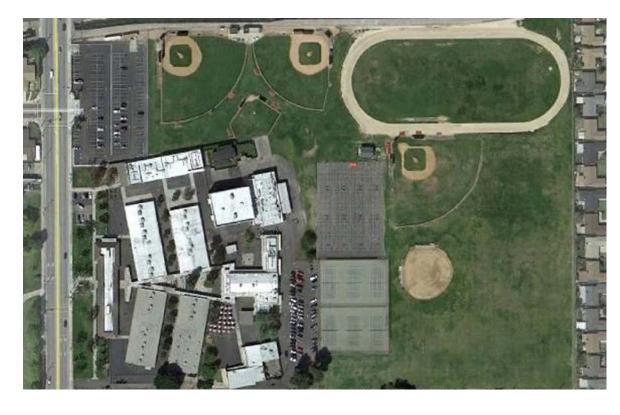
- ▶ Upgrade campus buildings.
- Improve parking lot vehicular and pedestrian traffic flow.
- Upgrade science labs and adequately house the science program.
- ▶ Correct drainage issues throughout campus.
- ▶ Add security fencing. Fencing replacements needed throughout.
- ▶ Need to replace gym bleachers.
- Need a drinking fountain at the playfields and at the cafeteria.
- Interior and exterior of existing campus buildings needs to be repainted.
- Improve curb appeal.

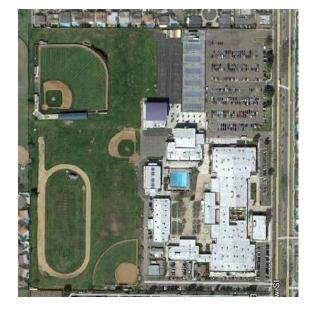
- o Dance room.
- o Cheer storage.
- o Food serving and speedlines.
- Address path-of-travel issues throughout the campus.
- Need for lunch shelters.
- Reconstruct tennis courts providing correct orientation.

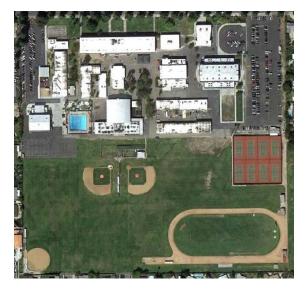
placement of shade structures are required.

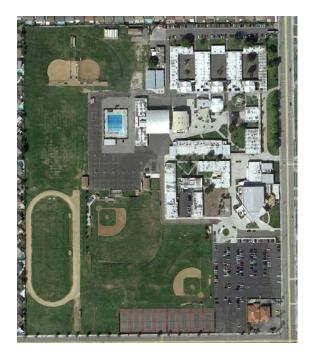
- Address needs in the Performing Arts Center.
- Address poor acoustics in multipurpose room MP1. Explore the possibility of this room converting to a student union.
- Athletics:
- o Need custodial closet in boys locker room.
- o Existing gym lockers are too narrow, helmets do not fit. Address boys & girls locker issues.
- o Missing floor drains in locker rooms.
- o Restore hose bibs.
- o Need to renovate tennis courts.
- o Replace backstop on main baseball field.

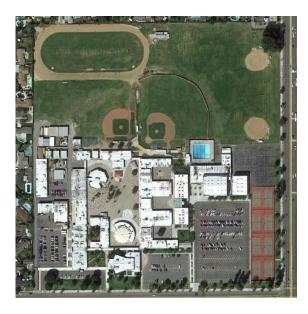
CONDITION ASSESSMENT

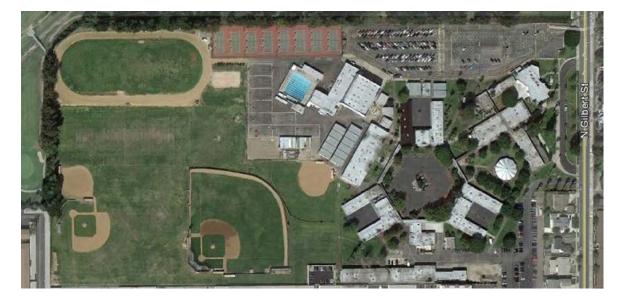
- ▶ Provide a secure location for the band trailer.
- Provide service road to loop around campus.
- New bike enclosure.

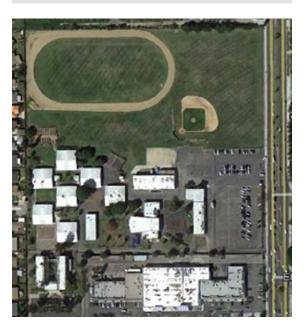
CONDITION ASSESSMENT

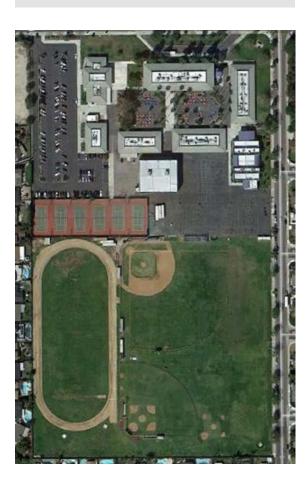
CONDITION ASSESSMENT

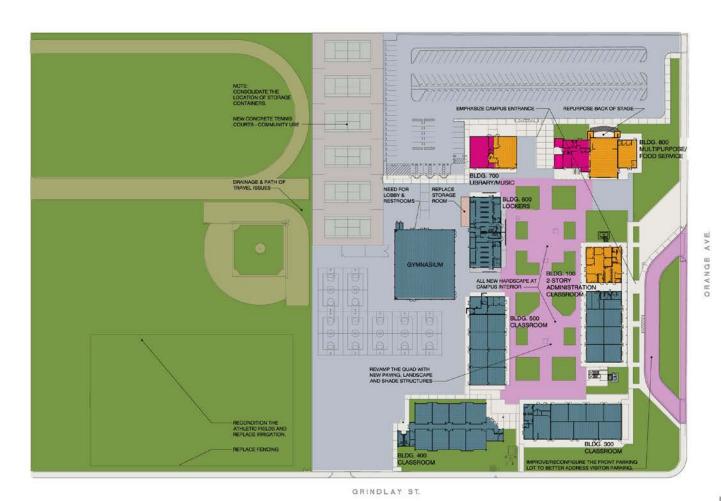
FACILITY CONDITION INDEX (FCI)
