3.4 PLANNING CONSIDERATIONS FACILITY CONDITION ASSESSMENTS SUMMARY

SOUTH JR. HIGH SCHOOL

2320 E. South Street
Anaheim, CA 92806

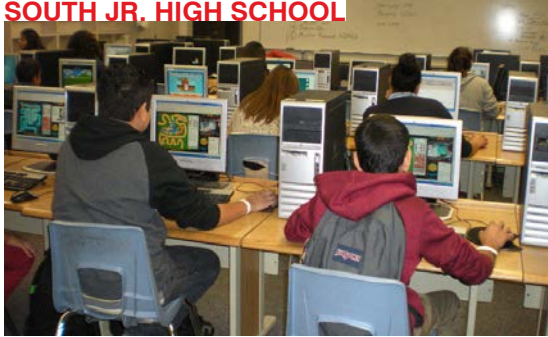
Need more technology to meet Common Core requirements.

Currently, South JHS has 13 science teachers but only 7 science labs. After QEIA reductions, they will still need 3 more labs. Common Core testing will additionally require 3 or 4 mobile computer labs.

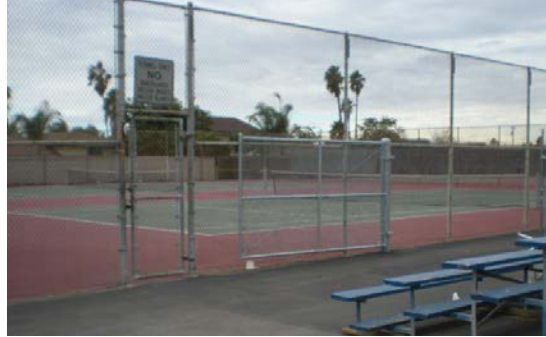
Need to refurbish tennis courts.

The existing playing fields (9.4 acres) are in good shape but some reconditioning is required. Field irrigation and smart controller are in good condition. The track is not draining properly and flooding/ponding occurs at the south end. The tennis courts require resurfacing (35,500 s.f.), new fencing and windscreens.

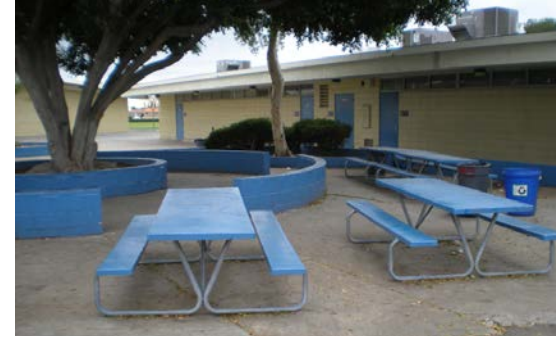
Need lunch shelters throughout campus.

The central quad needs to be redesigned to include new hardscape, seating, landscape, irrigation with a smart controller, and event lighting. Add new lunch shelters throughout the campus. The existing digital marquee is new.

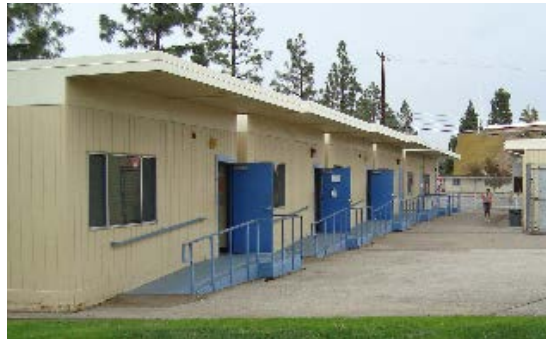
9 QEIA portables will be removed soon. Propose second bus drop off area.

While the front drop-off and parking lot were recently renovated, some site work remains. A second bus drop off along South Street will be master planned.

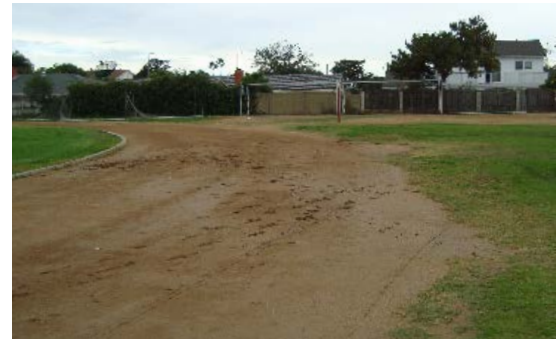
Playing fields need reconditioning.

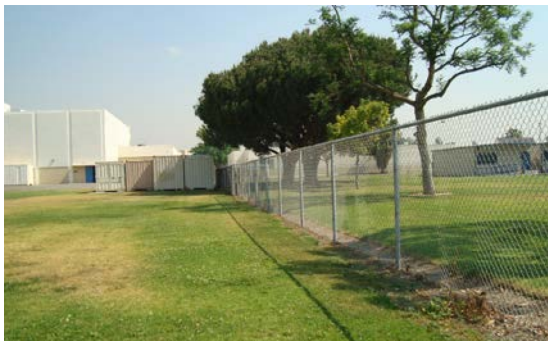
Replace the low fence at the neighboring school and park.

Additional fencing is required to secure the campus. Complete the ornamental fencing along South Street. Replace the 3' high fence along the east property line (3,000 l.f.). Add fencing between the campus and the playfields to secure the campus. The area behind Building 16 needs to be closed off.

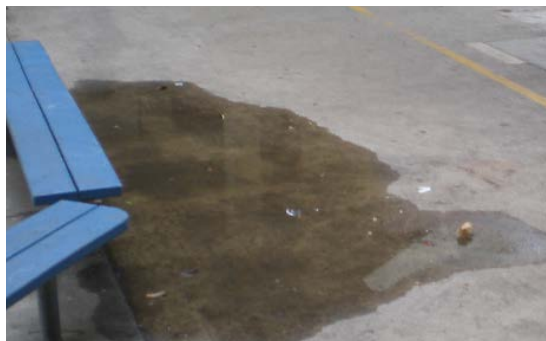
Ponding/drainage issues need to be addressed.

The existing underground storm drainage system has blockages that cause ponding at various areas of campus. A camera should be run to determine location of clogging due to tree roots.

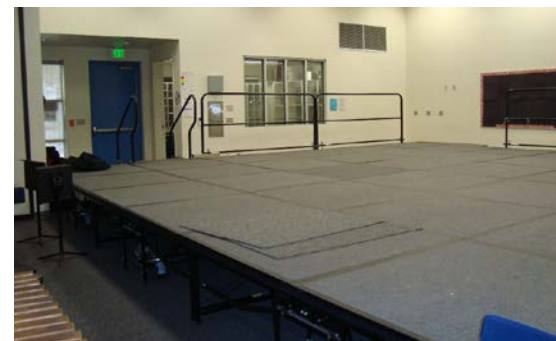
Replace the portable stage with permanent.

A major need at South JHS is to relocate the band room from the new multipurpose building. The multipurpose building needs a permanent stage and an operable partition.
