# 3.4 PLANNING CONSIDERATIONS FACILITY CONDITION ASSESSMENTS SUMMARY

## WESTERN HIGH SCHOOL

501 South Western Avenue  
Anaheim, CA 92804

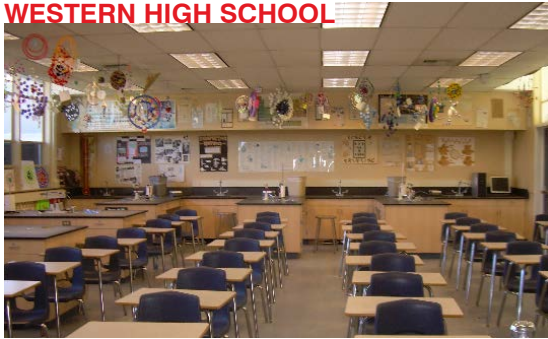
Provide adequate science facilities.

This school is in need of adequately housed and equipped science and computer labs to meet S.T.E.M. requirements.

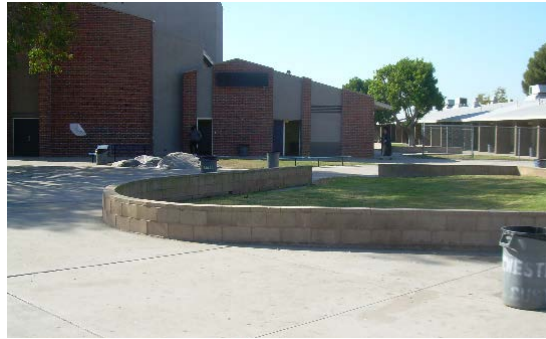
Revamp campus quad.

Revamp the entire central quad to include hardscape, landscape, irrigation with smart controllers, seating areas, shade structures and event lighting. Repurpose classroom courtyards to outdoor learning environments with enhanced technology. Address severe ponding in these areas.

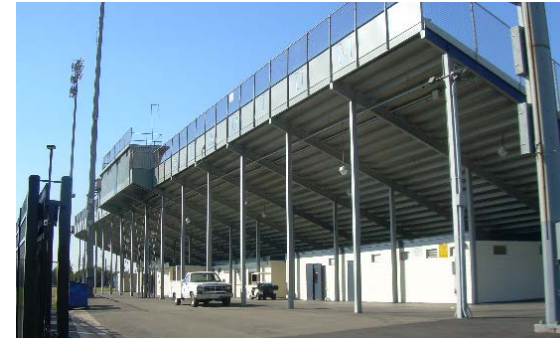
Stadium is in need of renovation

- o Upgraded restrooms and team rooms.
- o ADA parking
- o Bus parking
- o Perimeter ornamental steel fencing
- o Security system with cameras
- o Synthetic track and field
- o Replace visitor bleachers
- o New ticket booth and concessions

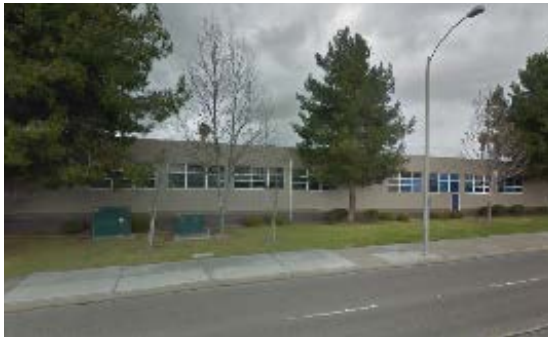
Campus in vital need of fencing/security improvements

Campus security is a major concern at Western High School with the need to address ongoing theft and vandalism. Tall fencing is required at the perimeter. Provide chainlink fence (3,100 l.f.) at east and west of fields. Complete the masonry fence (800 l.f.) along the north property line. Provide ornamental steel fence (2,500 l.f.) along the south side of the pedestrian easement and along Orange Avenue.

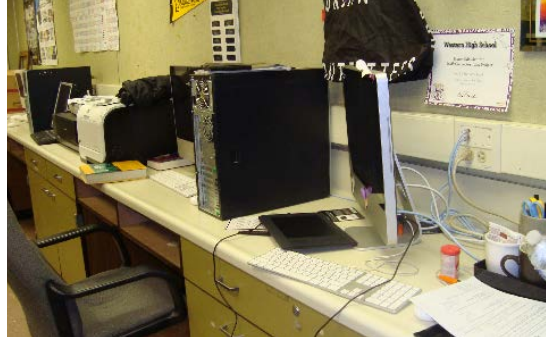
Upgrade computer labs to meet Common Core

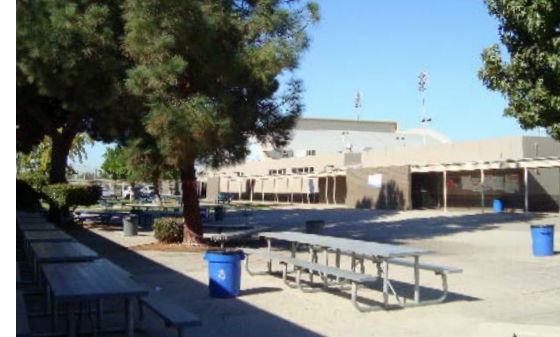
Add lunch shelters.

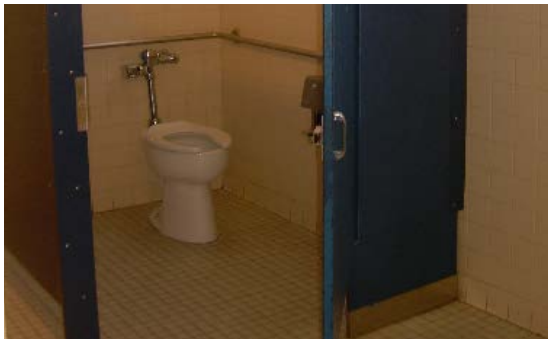
Upgrade and expand restroom facilities.

The existing restrooms need upgrading. Additional restroom facilities are needed. Replace the student store. The portable classroom buildings are new, on concrete foundations, and in good condition. Re-key the school to the District standard keying system. The majority of the window systems need replacement. Provide new window coverings throughout. It is imperative to maximize the functionality of the small site with the addition of two-story facilities.

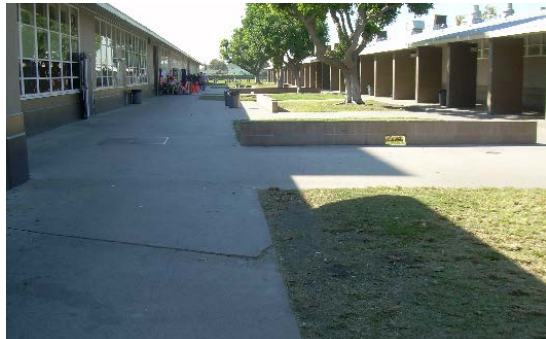
The asphalt paving at the main parking lot and areas between classrooms is in poor condition (247,000 s.f.). The central quad and finger wing concrete paving is in poor condition (97,000 s.f.) with several ADA compliance issues. There are several areas where the cross slope exceeds 2% and where the

slope in the direction of travel exceeds 5% without handrails.

Overall paving in poor condition across campus.

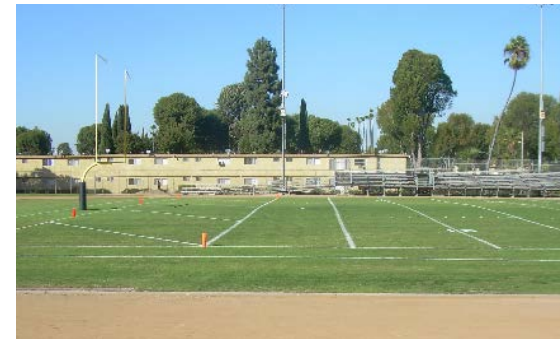
New synthetic track and field at stadium.
