# PLANNING CONSIDERATIONS FACILITY CONDITION ASSESSMENTS SUMMARY

BROOKHURST JR. HIGH SCHOOL

601 North Brookhurst Street  
Anaheim, CA 92801

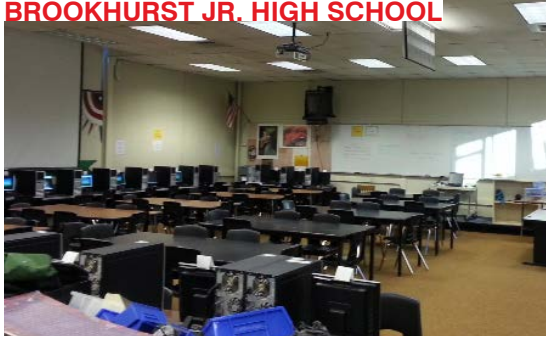
Need additional science, STEM and computer labs.

The Media Center is undersized and in need of an expansion/upgrade. Brookhurst JHS is currently lacking science, STEM, and computer labs. At present, there are 8 science teachers with only 4 science labs. It was suggested converting the underutilized old woodshop, Classroom 11, to a STEM Lab. He also suggested converting the large Classroom 19 to a STEM video production facility. Finally, it was suggested Classroom 32 be converted to a Science Lab as it is 1/3 larger than a standard classroom. The band room requires additional storage.

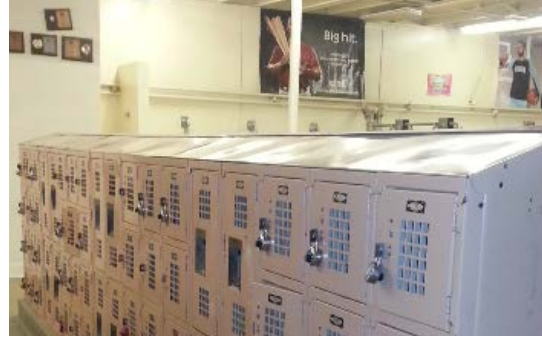
Locker rooms need additional lockers.

The boys and girls locker rooms are in poor condition. In addition to standard upgrades, more P.E. lockers are required. The roof skylights and ventilation in the gym need to be addressed.

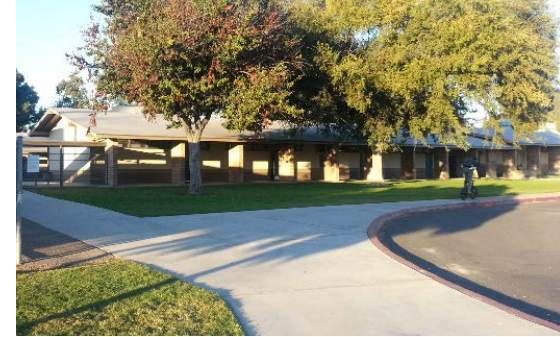
Need to reconfigure campus entry/exit.

Parking, drop-off, access, and wayfinding at the campus are difficult. What appears to be visitor parking along Brookhurst Street and Crescent Ave. is not meant for public use. Visitors are supposed to park in the large lot to the northeast, but that is not made readily clear. The Administration Building is set back from the perimeter which requires visitors to enter campus prior to passing through security areas. It is recommended that campus administration be moved and the entry/exit traffic along Brookhurst St. (high speed traffic) and Crescent Ave. (safer) be reconfigured to address these multiple issues. Parking should also be evaluated.

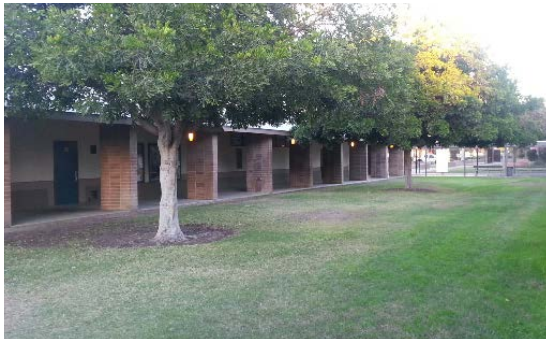
Convert turf courtyards to paved outdoor learning areas.

The finger plan design with tree lined courtyards between the buildings has presented problems. The trees have impacted the sewer and domestic water lines running through the same courtyards. The courtyards and quad are subject to ponding and flooding as is the north edge of the track. The courtyard spaces are underutilized on this small

campus and could be converted to outdoor learning areas. (63,000 s.f.).

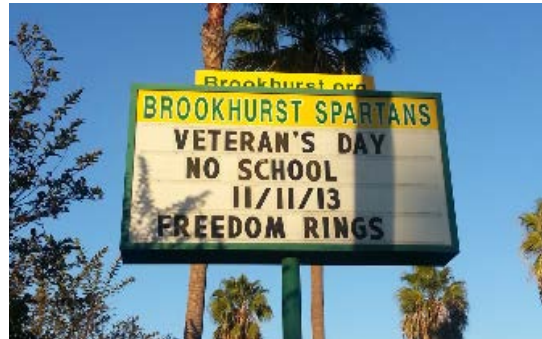
Upgrade campus marquee to digital format.

The lunch areas lack shelter and need shade structures as currently there are none. The campus marquee should be upgraded to digital.

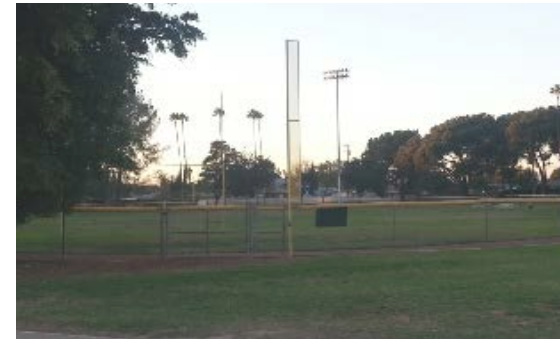
Need to install tall security fencing.

School security is an ongoing concern. Tall perimeter fencing needs to be added at the adjacent city park (1,320 l.f.), along Brookhurst at the northeast (960 l.f.) and along Crescent Ave (600 l.f.).

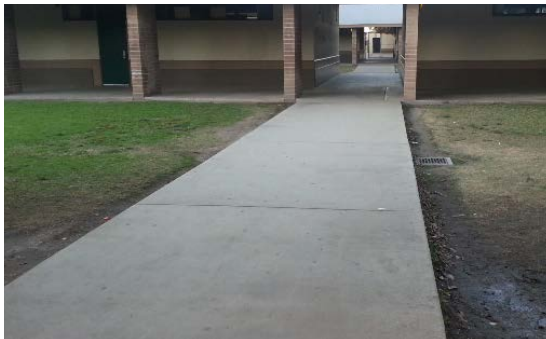
Widen concrete sidewalks.

The campus hardscape is in need of considerable improvement. Much of the existing asphalt paving area is in poor condition (121,200 s.f.). The Brookhurst St. and Crescent Ave. parking lots need to be reconfigured (17,200 s.f.). Much of the concrete paving is broken and cracked (19,000 s.f.). Existing walkways are too narrow and need to be replaced (35,000 s.f.). The existing drinking fountains also need to be replaced to address accessibility concerns.

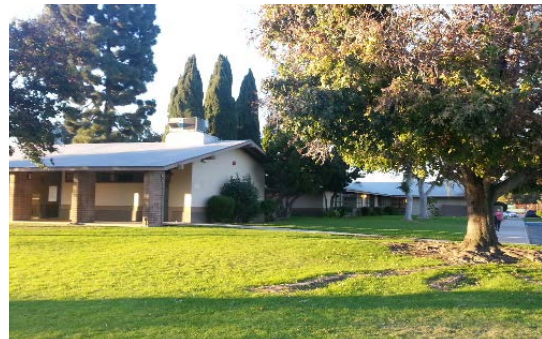
Campus wayfinding is difficult.

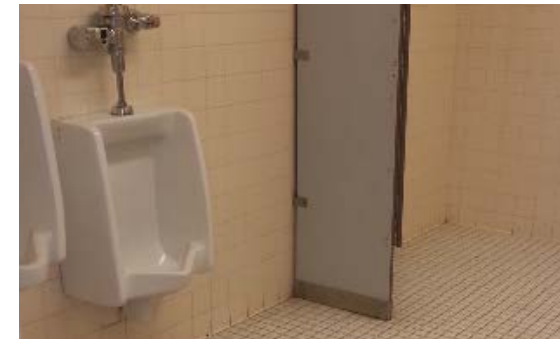
More restrooms needed on campus.

Brookhurst JHS was last modernized over twenty years ago in 1993 and the existing interior finishes are worn and need to be replaced. Classroom ceiling tiles are sagging. A major portion of the door hardware needs to be replaced to meet ADA requirements. The existing restrooms need upgrading. Additional restroom facilities are needed.
