PLANNING CONSIDERATIONS FACILITY CONDITION ASSESSMENTS SUMMARY

CYPRESS HIGH SCHOOL

9801 Valley View Street
Cypress, CA 90630

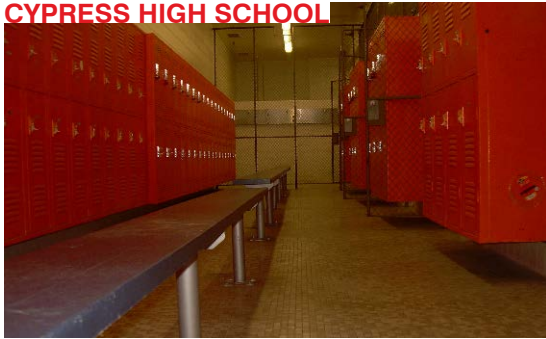
Revamp locker rooms.

The locker rooms need to be revamped. Add a sufficient number of lockers. The Quonset hut at the athletic fields should be replaced. Consolidate storage bins on a concrete pad. Replace the exterior wooden movable bleachers. Add storage for cheer and wrestling mats.

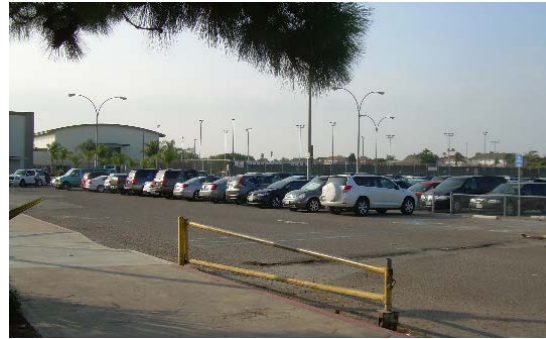
Major vehicular parking and circulation problems at student lot.

Vehicular parking, traffic circulation and exiting from the student parking lot (163,175 s.f.) are a major problem. The asphalt is in poor condition and needs to be replaced. The addition of a traffic light at Valley View St. has been suggested for safety concerns as well as to relieve congestion during peak drop-off times. There is also a desire to improve curb appeal along Valley View St.

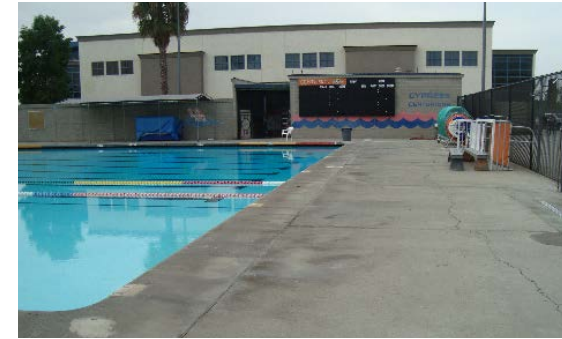
Pool in need of standard modernization.

A standard modernization of the pool is required including new plaster, deck resurfacing, pool covers, starting blocks, pool storage, and pool lights. Consider variable frequency drives (VFD) for the pump motors.

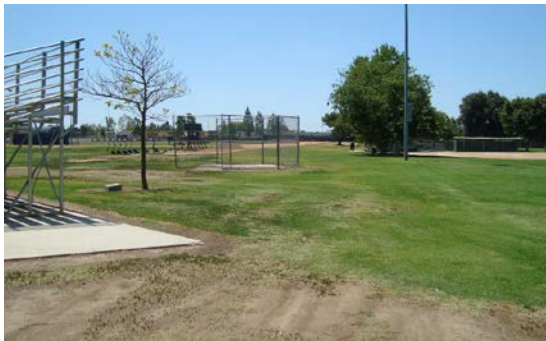
3,750 l.f. of fencing is required to properly secure the site.

There are ongoing security concerns. The property line for the campus needs to be defined and secured. Some classrooms open directly to the front of the campus without fencing or a perimeter barrier. Fencing is needed to separate the playing fields from Oak Knoll Park on the northwest side of the campus. Approximately 3,750 linear feet of fencing is required to properly secure the site.

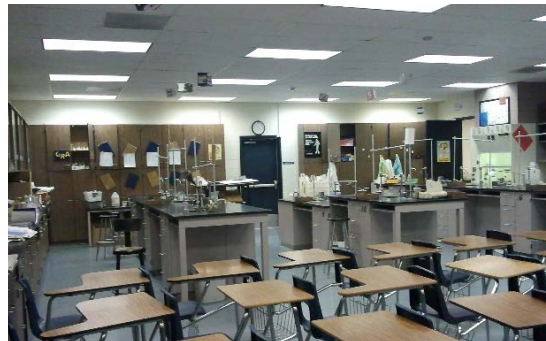
Need additional science labs to meet STEM requirements.

Currently, Cypress High School is in need of three science labs to meet STEM requirements. The Special Education program is concentrated in a small area on campus instead of being properly dispersed and is also in need of sensory/focus rooms. The dance room is in need of expansion and a dance floor. The theater is in need of modernization including lighting, sound system and valances.

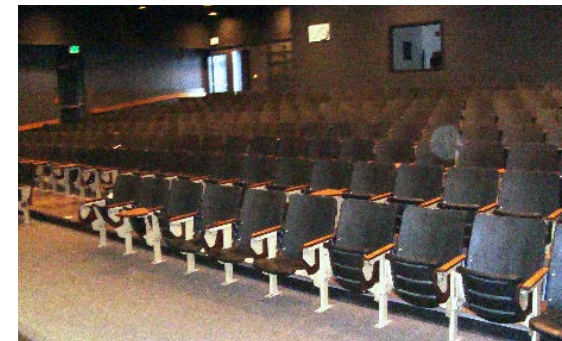
Theater needs upgrades.

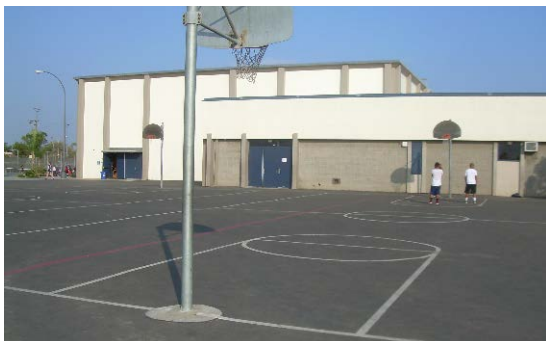
Basketball and tennis courts need to be reconfigured.

improvement. The sports fields need to be reconditioned and the irrigation system replaced with a connection to the existing smart controllers. Various areas on campus need new irrigation and smart controllers. The existing tennis and basketball courts need to be replaced and reconfigured. Determine a final location for the band trailer. Address ponding at the track and at the JV soccer field. Existing bike racks are in good condition.

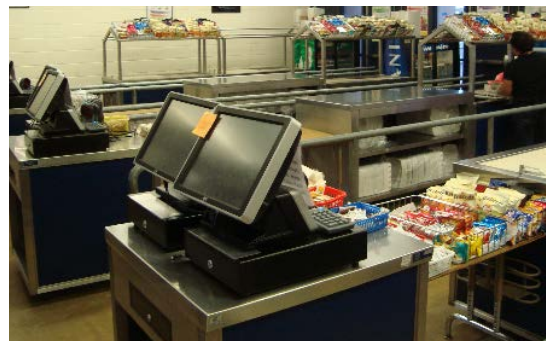
Food service area is in need of additional speed lines.

The existing food service area is in need of an upgrade. Currently, 2,700 students are served within a 1/2 hour time period in an undersized space. This area should be expanded with the addition of speedlines.

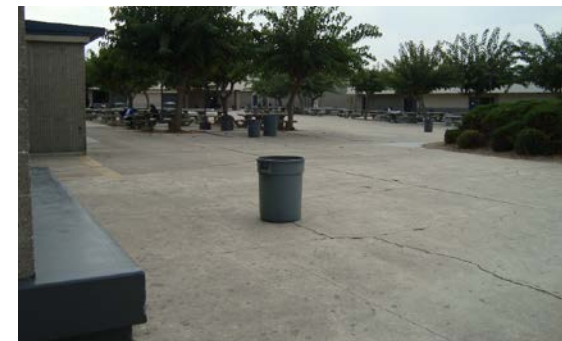
Upgrade central quad.

The condition of the existing quad area, which encompasses 81,000 s.f., is extremely poor with extensive cracking, lifting and slope issues as well as ponding. Numerous ADA compliance issues must be addressed. The quad is also in need of new lunch shelters, hardscape, landscape, technology, a new outdoor stage, and event lighting.
