# 3.4 PLANNING CONSIDERATIONS FACILITY CONDITION ASSESSMENTS SUMMARY

DALE JR. HIGH SCHOOL

900 S. Dale Avenue  
Anaheim, CA 92804

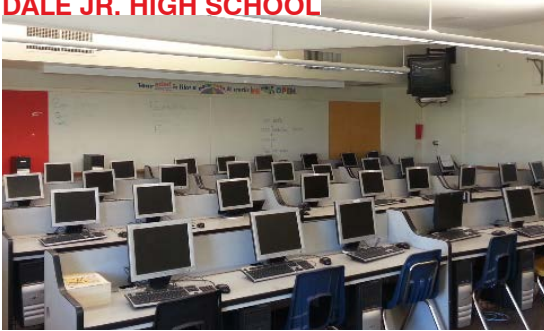
More computer labs needed to meet Common Core.

The band, choir, and art rooms need to be adequately sized. The school currently needs 6 science labs adequately sized and equipped to meet STEM requirements. The school needs 4 computer labs to meet Common Core requirements. The Bridges program needs to be properly housed.

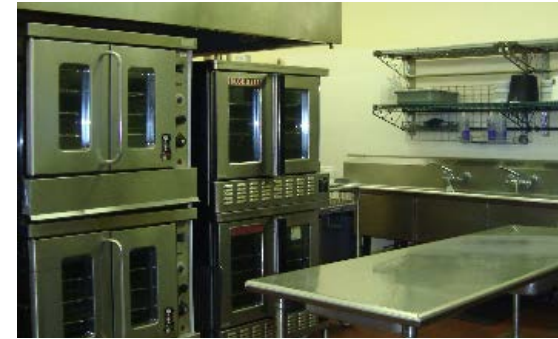
Potential location for new AUHSD central kitchen.

As Dale JHS is being considered for the location of the District's new central kitchen, two areas on site are under evaluation. One is the Polaris building location and the other is a lesser used area of campus at the southeast corner of the site located off Ball Road.

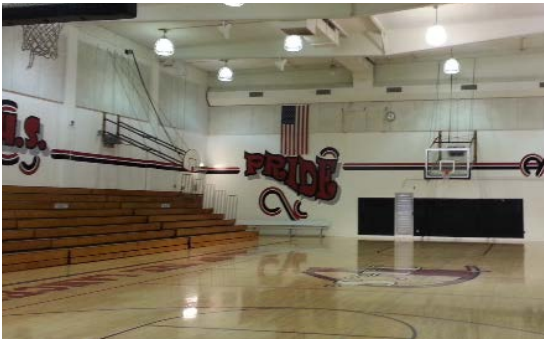
Gym floor and bleachers need to be replaced.

The boys and girls locker rooms are in poor condition. In addition to standard upgrades, provide more P.E. lockers. A direct connection needs to be made between the locker rooms and the gym. The gymnasium floor needs to be refurbished. The bleachers need to be replaced.

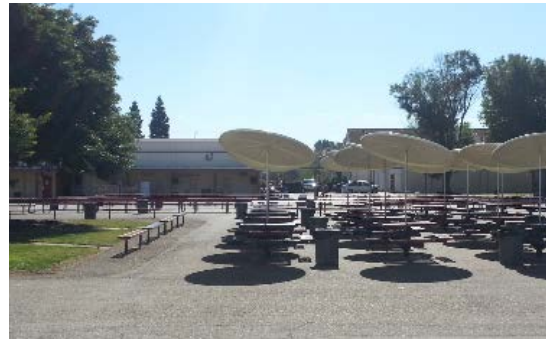
Campus quad needs redesign, shade structures, & stage.

The central quad is in need of a major upgrade. Provide hardscape, landscape, irrigation with smart controllers, seating areas, shade structures, and event lighting. Address path-of-travel issues throughout the site. Accessible hi-lo drinking fountains are required. Provide outdoor stage.

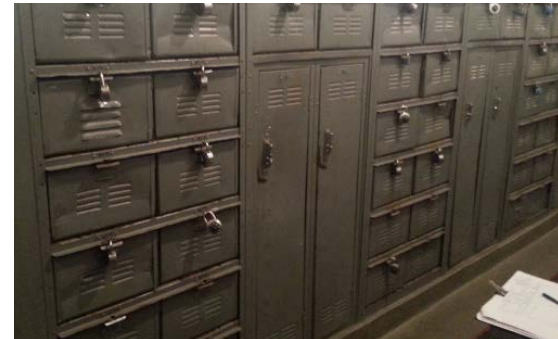
Locker rooms are in need of reconfiguration and additional PE lockers.

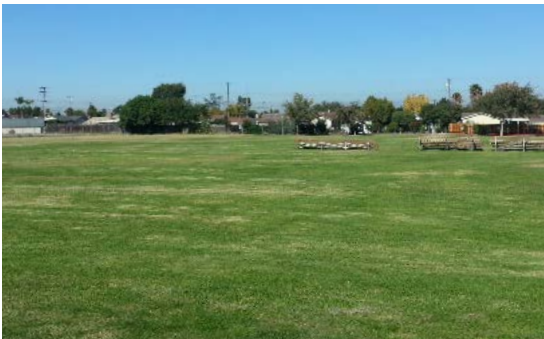
Playing fields need reconditioning.

The campus irrigation system is hydraulic and needs to be replaced (11.5 acres) including the south playfield. The field irrigation is poor in general and the playing fields need to be reconditioned.

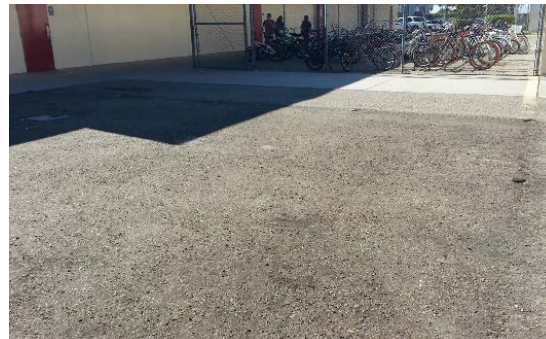
Campus-wide paving is in poor condition.

The asphalt paving on campus is in poor condition. Replace 67,000 square feet of asphalt at the central quad and classroom wing courtyards as well as 130,000 square feet of asphalt at the front and rear staff parking lots. The north parking lot is in poor condition (68,000 s.f.). Concrete paving (20,000 s.f.) needs to be replaced at various locations throughout the campus.

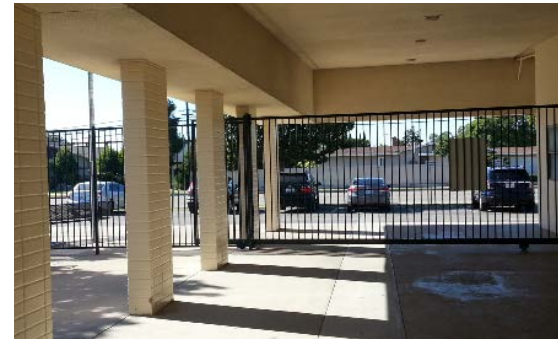
Need to install 8' tall fencing along Ball Road.

The campus perimeter is in need of security improvements. Four hundred linear feet of 8' tall chain link fencing is required along Ball Road and 800 linear feet of additional fencing will be required at the northwest side of campus if the new central kitchen is constructed on that location. The design of the front drop-off parking lot should be reconfigured for efficiency. Improve curb appeal along Dale Avenue.
