# PLANNING CONSIDERATIONS FACILITY CONDITION ASSESSMENTS SUMMARY

MAGNOLIA HIGH SCHOOL

2450 W. Ball Road  
Anaheim, CA 92804

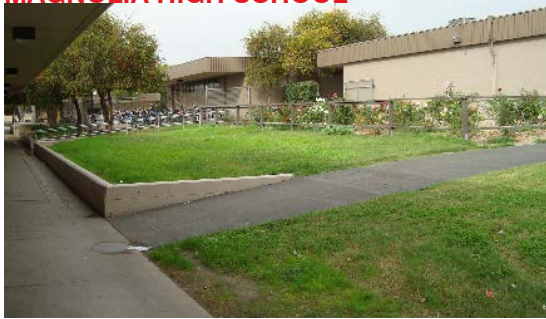
Need to replace 15 portables with permanent classrooms.

standard classrooms, 7 science labs, 4 computer labs, 2 art rooms, 1 band, 1 choral, 1 home economics, 1 wood shop, 1 photo shop, 15 standard classrooms in portable units and 2 “Bridges” portable units. Magnolia High School currently has 15 portable classrooms on the southwest side of the campus that need to be converted to permanent.

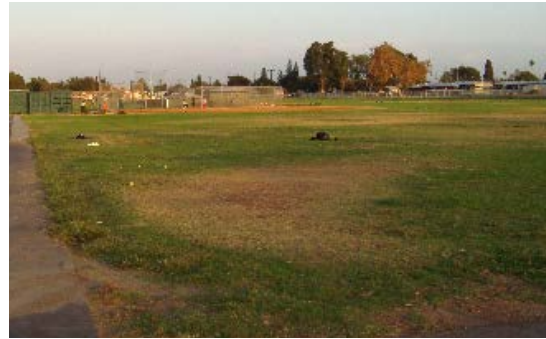
Need to recondition fields.

All the playing fields (20.5 acres) need to be reconditioned. Some of this acreage is under consideration as a potential site for a new District stadium given the central location of the school, open space, and proximity to available parking. The movable wooden bleachers in the gym need to be replaced and a second (practice) gym added.

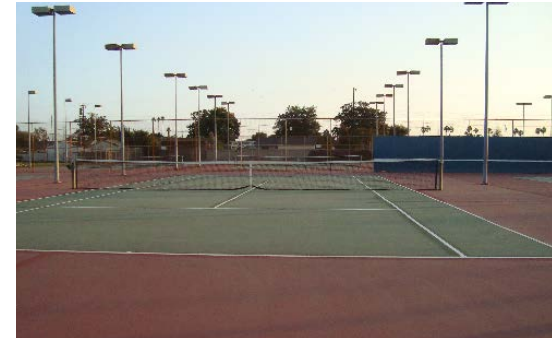
Tennis courts need to be replaced.

The asphalt paved tennis courts (56,800 s.f.), fencing and wind screens need to be replaced. A standard modernization of the pool is required, including new plaster, deck re-surfacing and replacement of pool lights. The District should consider the addition of pool covers and variable frequency drives (VFD) for the pump motors.

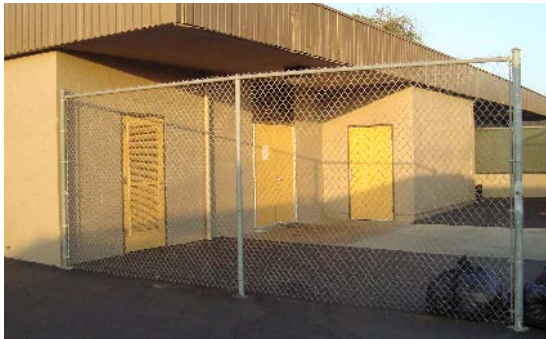
Need 4,000 l.f. of fencing to secure campus.

Security is an ongoing concern at the Magnolia High School campus. Approximately 4,000 linear feet of fencing is required to secure the campus.

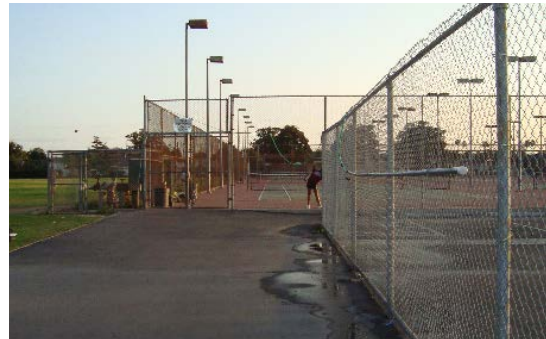
Minor ponding and drainage issues on campus.

While the roofing is in good condition, a maintenance tune up will be needed in the near future. The down spouts to grade are causing some flooding issues. There is also some minor ponding throughout campus. A storm chamber system was installed in 2012 to correct storm water run off problems. Most of the campus window systems are very old and in need of replacement.

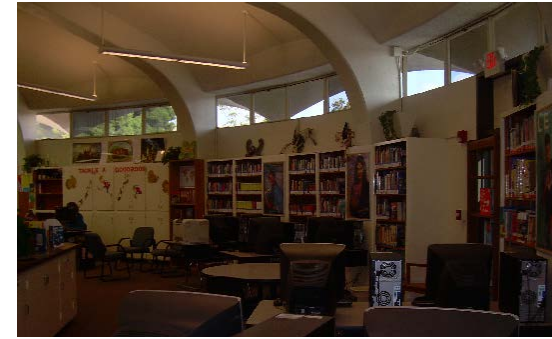
Need student union / media center for student interaction and collaboration.

The existing library is undersized. A Student Union/ Media Center with sufficient computers, books, and gathering areas is a high priority.

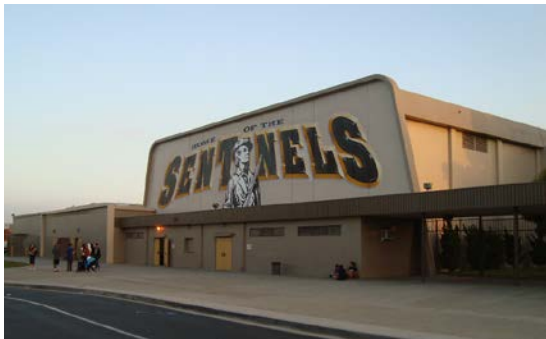
Need to add a second (practice) gym.

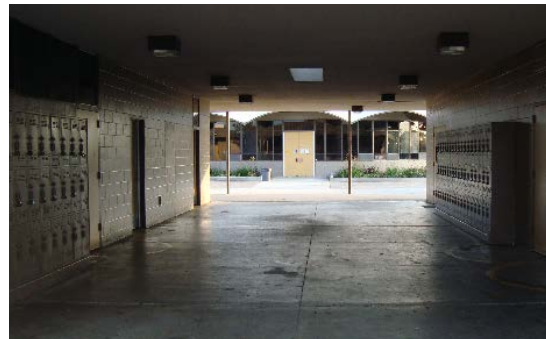
Need to remove lockers at finger plan buildings and courtyard.

The western side the central quad (35,000 s.f.) still needs to be upgraded. The school needs new lunch shelters. Replace the worn fabric on the existing shelters. Lockers need to be removed at the finger plan buildings and courtyards. The campus trash bins need enclosures. There are elevation changes throughout the site that need to be reevaluated for ADA compliance.

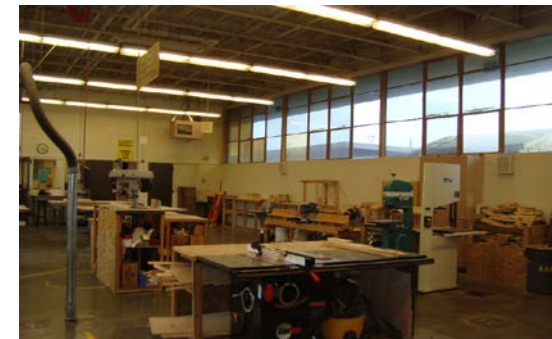
Most campus windows are old and need replacement.
