PLANNING CONSIDERATIONS FACILITY CONDITION ASSESSMENTS SUMMARY

ORANGEVIEW JR. HIGH SCHOOL

3715 West Orange Avenue
Anaheim, CA 92804

Year Constructed 1958
Year Last Modernized 1993

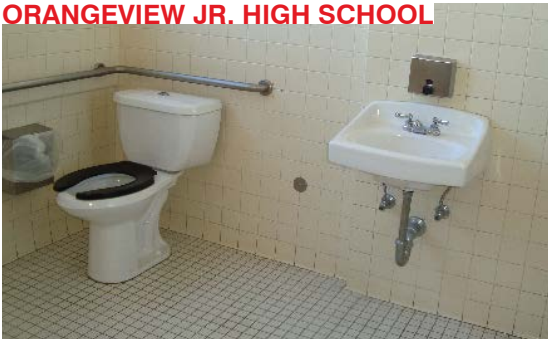
Campus restrooms are in need of an upgrade.

Orangeview JHS was last modernized over twenty years ago and the existing interior finishes are worn and need to be replaced. Classroom ceiling tiles are sagging. A major portion of the door hardware needs to be replaced to meet ADA requirements. The existing restrooms need upgrading. Additional restroom facilities are needed.

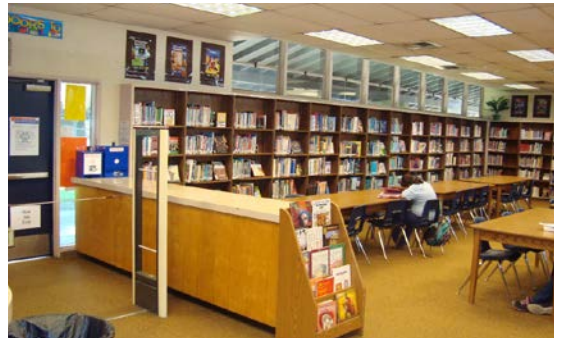
Need to renovate Library/Media Center.

The school is in need of 5 new science labs to meet Common Core requirements. Space is also needed for Counseling. The existing Media Center is undersized and should be expanded along with technological upgrades.

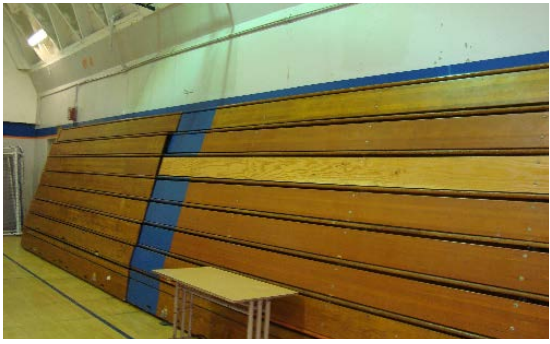
Need to replace gym bleachers.

There are several issues to be addressed at the gymnasium including the need for new bleachers. The leaking roof skylights need to be addressed. The girls and boys locker rooms, including the coaches office, need to be modernized. Showers need to be provided at an appropriate level. Lockers need to be replaced to meet the current need.

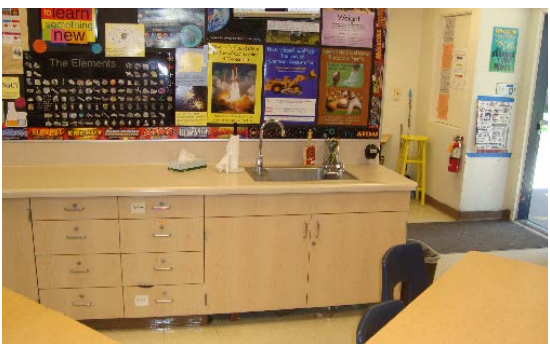
School is in need of 5 additional science labs.

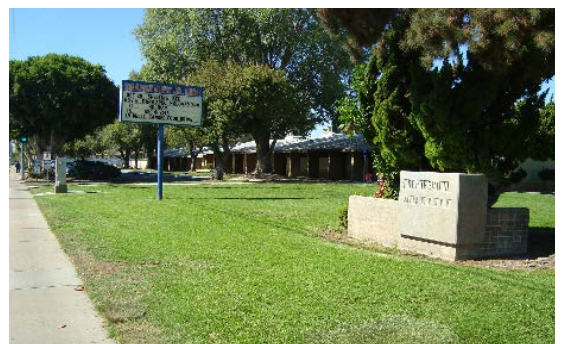
School entrance/site security is in need of redesign.

Parking, drop-off, access, and wayfinding at the campus are difficult. What appears to be visitor

parking along Orange Ave. encourages visitors to enter campus prior to passing through security areas.

It is recommended that the existing traffic and pedestrian flow be redesigned to improve issues with security, wayfinding and parking. Consider relocating the administrative offices to the front of campus and expanding the parking lot along the Orange Avenue entrance.

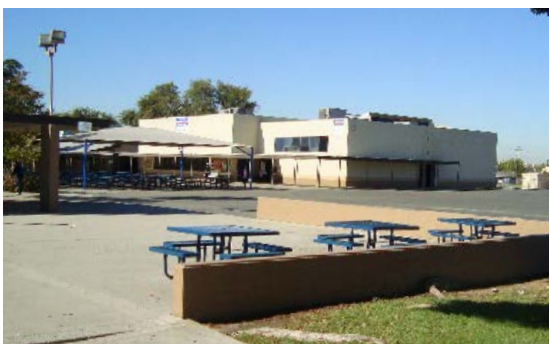
Lunch shelters need to be replaced/expanded.

Presently, the courtyard spaces are underutilized and could be converted to outdoor learning areas. The existing lunch shelters should be replaced with metal structures and a new shelter added to provide adequate shade. The covered walkways between buildings are currently very dark; it is recommended that skylights be added.

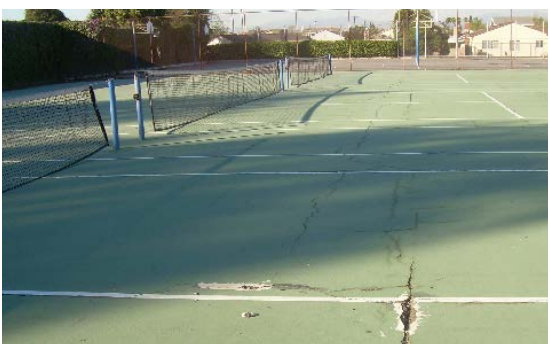
Tennis courts require resurfacing and/or replacing.

of a general renovation while addressing ponding issues at the north end of the track. The existing track is not a true size and should be reconfigured. The existing tennis courts (33,000 s.f.) need to be resurfaced with new fencing and windscreens added. Evaluate whether they should be relocated to a more appropriate location.

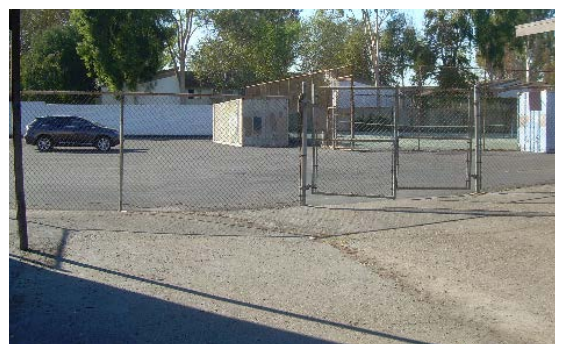
Major improvements are needed in security fencing.

There are major security concerns to address in the campus perimeter which requires 1,600 linear feet of new fencing.

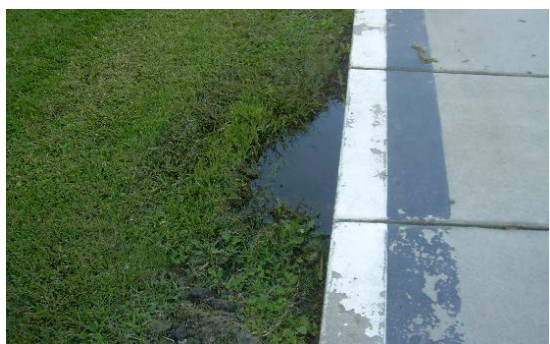
Address flooding/ponding issues between buildings.

The finger plan design with tree-lined courtyards between the buildings has caused utility and drainage issues at the campus. The trees have impacted the sewer and domestic water lines running through the courtyards. The courtyards are subject to ponding and flooding because sheet flow of runoff storm water is restricted.

The existing sewer, domestic water, and gas lines need to be replaced. Provide a gas earthquake shutoff valve. The storm drainage needs to be improved throughout campus.
