# PLANNING CONSIDERATIONS FACILITY CONDITION ASSESSMENTS SUMMARY

SAVANNA HIGH SCHOOL

301 North Gilbert Street  
Anaheim, CA 92801

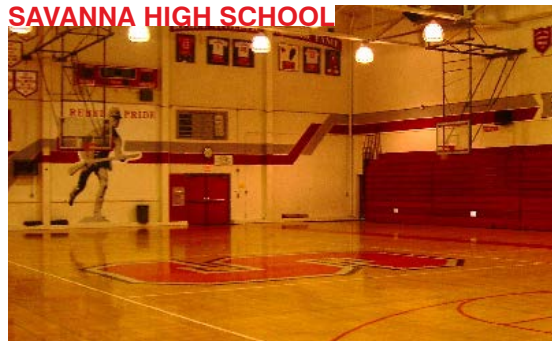
Gym and locker room improvements needed.

The school is in need of a second gymnasium, including a wrestling facility and extra P.E. storage. The existing athletic facilities also require upgrades. The gym needs to be renovated and expanded to include a foyer and motorized bleachers. The boys and girls shower/locker room, team rooms, and coaches areas are in poor condition. In addition to standard upgrades, provide P.E. lockers to meet need.

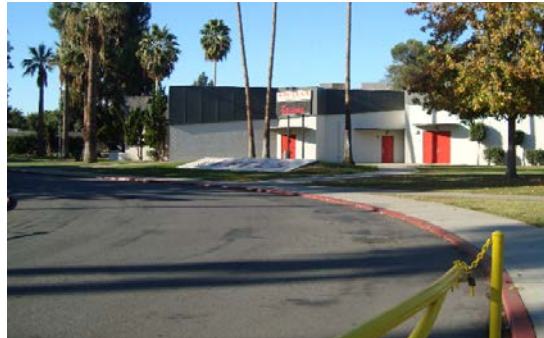
Major improvements needed to drop off and parking areas.

Traffic circulation, parking and drop-off conditions are poor and need to be reconfigured. The Gilbert Street visitor parking is too narrow to be effective. There is only one driveway to the north parking lot and it is not wide enough to accommodate traffic. The north parking lot should be reconfigured with student drop-off near the World Language area. The bus drop off

should be evaluated. More standard parking should be added in lieu of the parallel parking that currently exists.

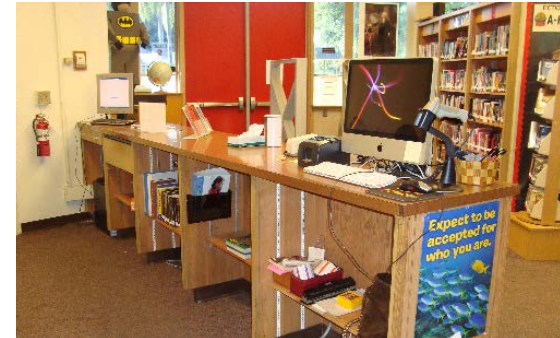
Library in need of renovation.

The administrative office and media center could be reconfigured to make better use of the existing space. The library is also in need of renovation/modernization. The Food Service area should be expanded with additional speedlines and covered lunch areas.

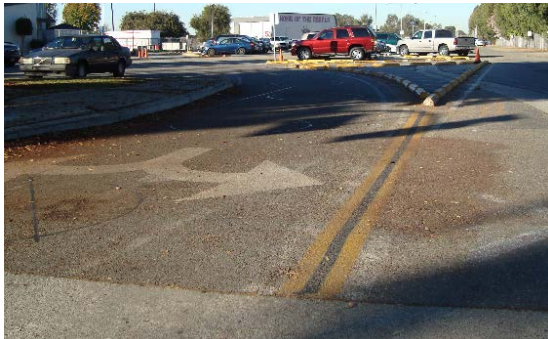
Reconfigure and upgrade main parking lot.

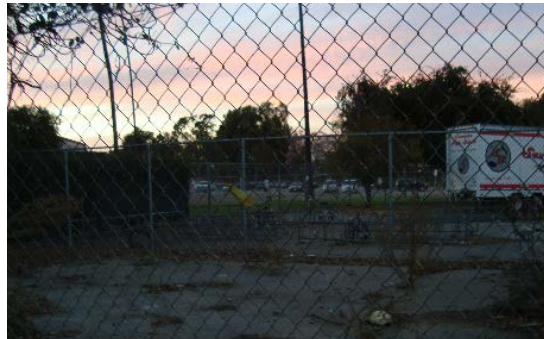
New fencing and security lighting needed throughout campus.

Fencing at the north and west side of campus between the school and golf course is in poor condition and needs to be replaced. High safety netting is needed along the north property line for safety. Coordinate with the city of Anaheim. Replace (2,800 l.f.) of chain link fence. Provide ornamental steel fencing along Gilbert Street and new main entrance to the campus (1,500 l.f.). The school staff has requested security lighting at the northwest corner of the fields due to the proximity of the neighboring golf course.

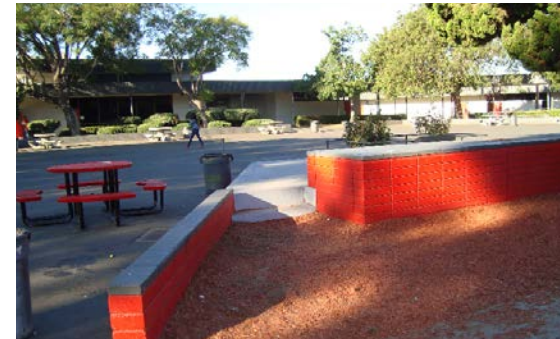
Revamp the central quad.

Revamp the entire central quad (42,000 s.f.) to include new hardscape, landscape, irrigation with smart controllers, seating areas, shade structures, and event lighting. Repurpose classroom courtyards (22,000 s.f.) to outdoor learning environments with enhanced technology.

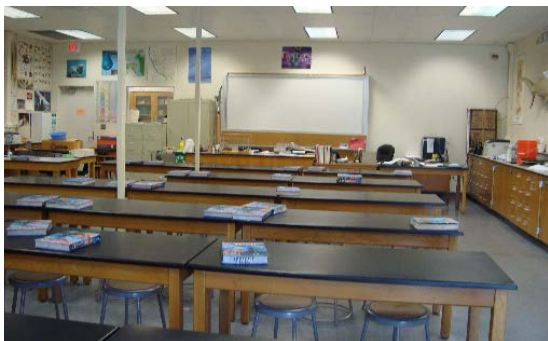
New science labs are needed.

The science program needs adequate housing to meet S.T.E.M. requirements.

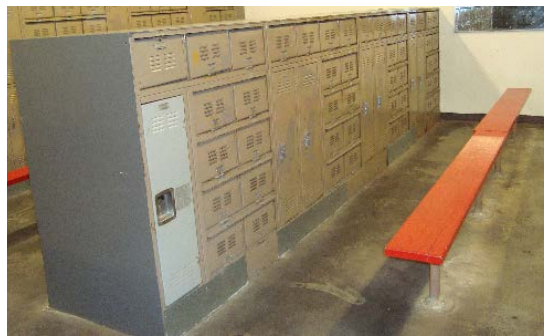
Upgrade athletic facilities.

The athletic fields are in good condition. However, the irrigation system needs full replacement, including a smart controller (18.8 acres). A paved road should be added to provide access to the fields. The track long jump and triple jump should be relocated for safety purposes along with the shot put which is currently sited in a poor location. The asphalt paved tennis courts need to be replaced with concrete and new play surface (58,000 s.f.). Replace fencing and wind screens.

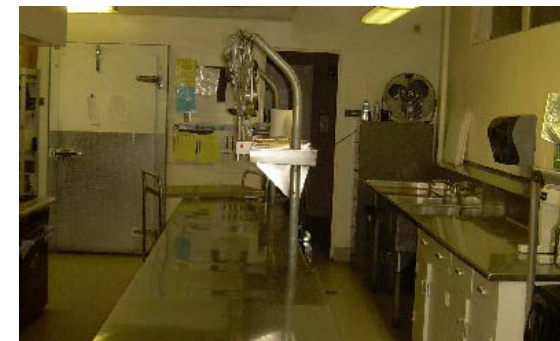
Kitchen in need of expansion, including speedlines.
