3.4 PLANNING CONSIDERATIONS FACILITY CONDITION ASSESSMENTS SUMMARY

WALKER JR. HIGH SCHOOL

8132 Walker Street
La Palma, CA 90623

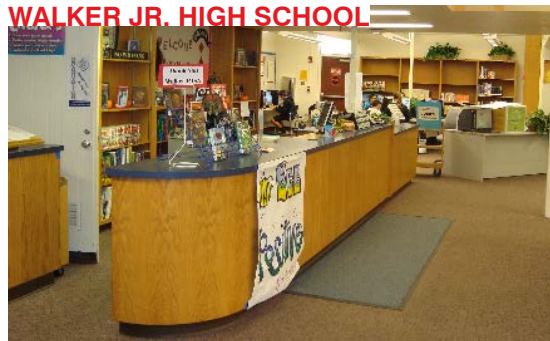
Administration building in need of reconfiguration.

The administration building needs to be reconfigured to improve functionality. The boys and girls shower/locker rooms and coaches areas are in poor condition. In addition to standard upgrades, provide P.E. lockers to meet need. The wooden bleachers in the gym need to be replaced. The MPR needs major modernization to include additional storage and new stage curtains.

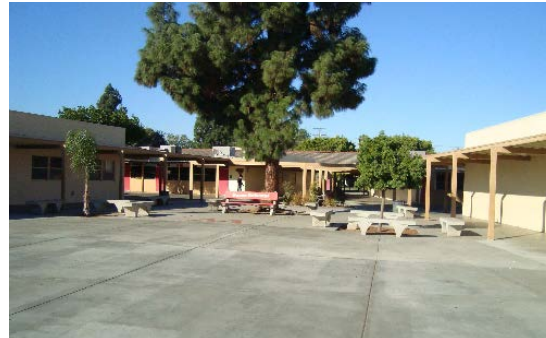
Convert courtyards to outdoor learning areas.

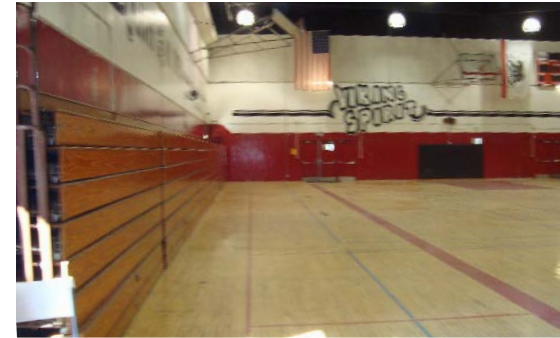
Need to replace gym bleachers.

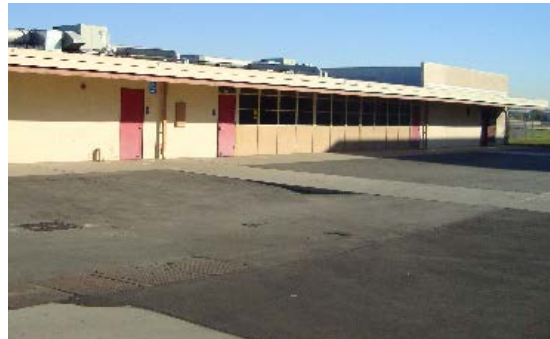
Existing paving in poor condition throughout campus.

The paving at Walker JHS is mostly in poor condition. Approximately 75%-100% of the existing asphalt (218,000 s.f.) and 50%-60% of the existing concrete (36,000 s.f.) needs to be replaced. Some path-of-travel and ponding issues need to be addressed in various areas.

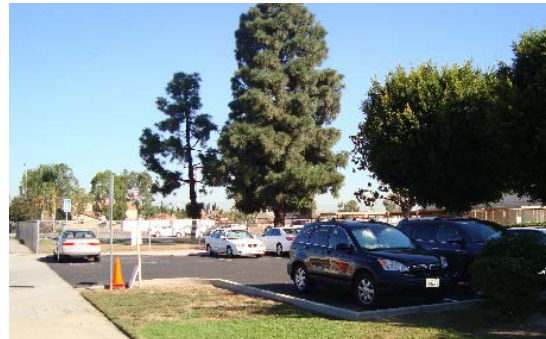
Reconfigure parking lots.

The existing parking lots along Walker Street need to be modified to improve curb appeal as well as vehicular and pedestrian traffic. Address security/safety issues.

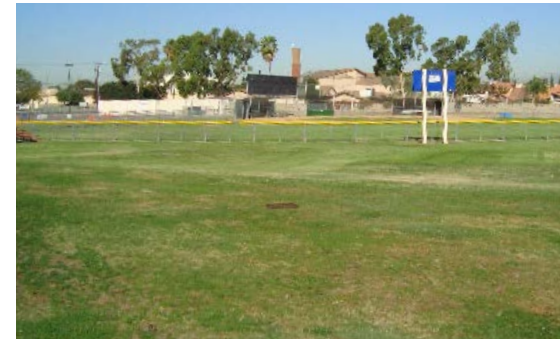
Existing field turf is in poor condition.

The existing playing fields are relatively level but the turf is in poor condition and needs reconditioning (11.4 acres). The irrigation system needs to be completely replaced throughout the campus, including smart controllers.

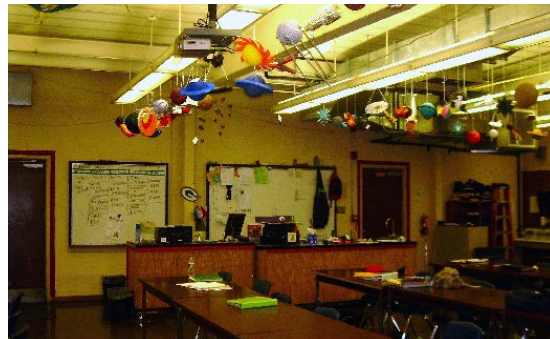
Buildings require major renovation.

The general condition of facilities at Walker Jr. High School is poor. The building envelope, interior finishes and site utilities are in need of repair and/or replacement. Walker JHS needs a major modernization. While the overall condition is poor, the structural integrity of the buildings is good.

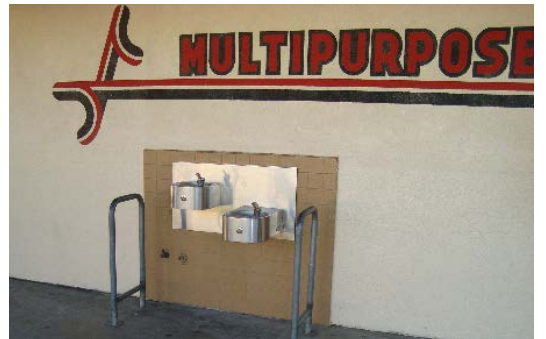
Interior/exterior of buildings need to be repainted.

A complete replacement of the existing window systems is needed. The interior and exterior of all campus buildings need to be repainted.

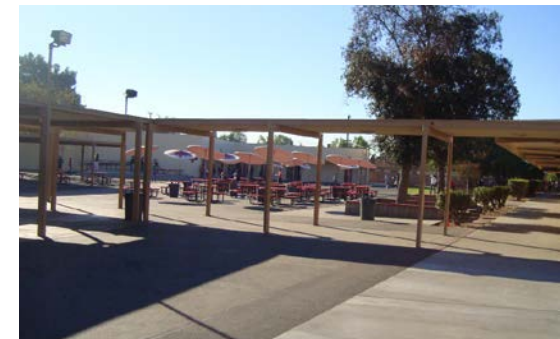
Upgrade the quad with seating and shade structures.

The lunch area is in need of new shade structures. The existing 20 X 20 shade structure needs to be replaced. The existing quad is in need of a redesign to include hardscape, landscape, seating areas, and event lighting.
